## Case study

## Electrolytic corrosion of water pipeline system in the remote distance from stray currents—Case study

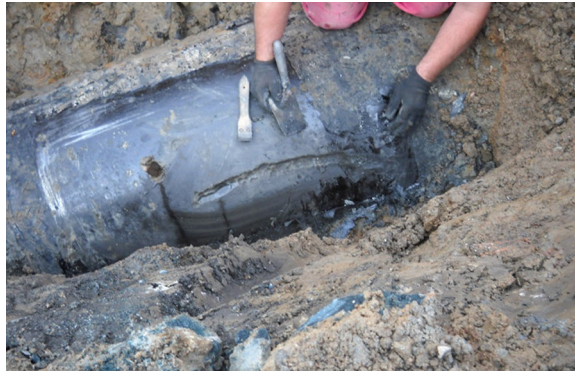
**Fig. 1.** View of pipeline corrosion failure.

The paper presents a case of corrosion of DN 300 underground water pipeline made of steel belonging to the water supply system of the city of Krakow and describes the methodology of undertaken corrosion diagnosis. Corrosion damage was caused by the effects of stray currents. The failure occurred despite a considerable distance (nearly a kilometer) from the crossing the tram and train with pipeline.

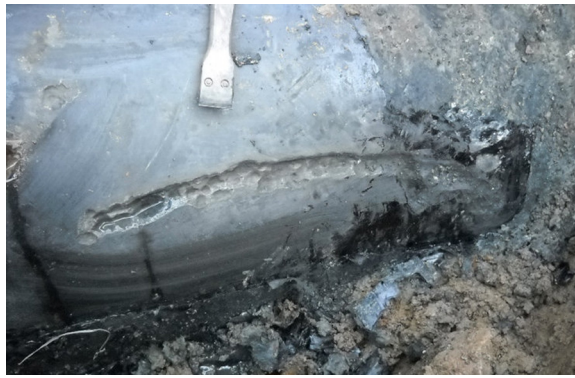
**Fig. 2.** Zoom on the defect site.
