Experimental investigation on the behaviour of square FRP composite tubes under repeated axial impact

Centre of Excellence in Engineered Fibre Composites (CEEFC), Faculty of Engineering and Surveying, University of Southern Queensland, Toowoomba, Queensland 4350, Australia

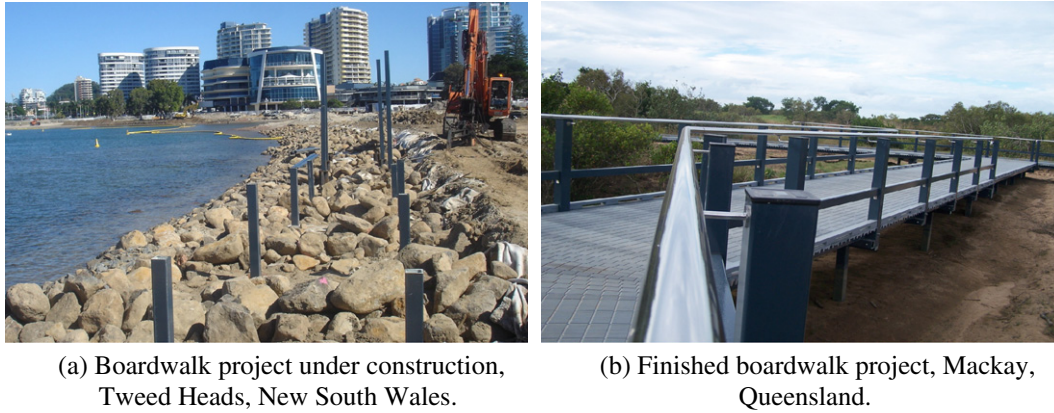
Fig. 1. Pultruded composite tubes used in shoring-up boardwalks. (Courtesy from Wagners CFT, Queensland, Australia.)

The emergence of fibre reinforced polymer (FRP) composite tubes as a structural component made these materials potential for composite pile. The high corrosion-resistant characteristic of FRP materials made them as suitable alternatives for piling application in harsh marine environment. Fig. 1 shows the FRP square pultruded tubes recently applied in Australia as hollow composite piles installed into the ground using impact driving. Driving these piles, however, requires more careful consideration due to their relatively low stiffness and thin walls. The possibility of damaging the fibre composite materials during the process of impact driving is always a concern. One of the main factors that affect the driving performance of these piles and needs special attention is the impact strength of the fibre composite materials [1]. Therefore, there is a need to understand the impact behaviour of these materials in order for them to be safely and effectively driven into the ground.
