Mechanical performance and medium-term degradation of rubberised concrete

^aC.T.G. S.p.A., Italcementi Group Research & Development Department – i.lab, via Stezzano, 87 c/o Km, Rosso 24126, Bergamo, Italy

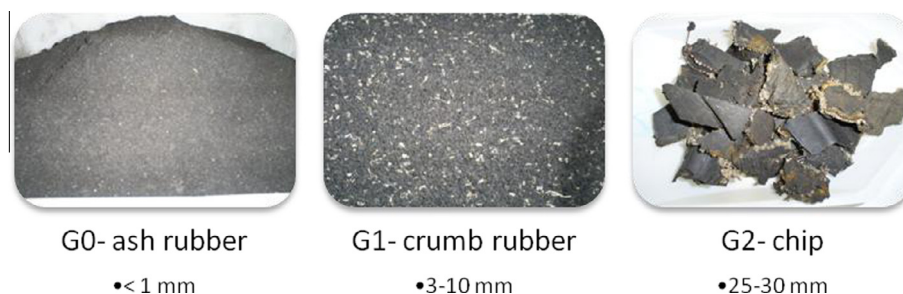
As can be noted in Fig. 1, the supply of chipped aggregates (G2-1) looks very heterogeneous, while the crumb fraction (G1-1) is more uniform with less amount of steel and tissue fibers. The aforesaid rubber samples were subjected to centrifugation to eliminate trapped air. The three specimens were sampled according to UNI EN 932-2 and the sieve analysis (test portion washed and then subjected to dry sifting) was conducted with the purpose of determining sieve distribution in accordance to UNI EN 933.

Fig. 1. Types of rubber used in the laboratory tests.

In this work, car-type tyres have been tested; three broad categories of discarded tyre rubber have been considered (Fig. 1):

- *Chip rubber*. The rubber was about 25–30 mm in size. It was used to replace the coarse aggregates in the concrete mixes.
- *Crumb rubber*. These rubber particles were highly irregular, in the range of between 3 and 10 mm. This rubber type was used to replace sand in the concrete mixes.
- *Ash rubber*. This rubber consisted of particles smaller than 1 mm. It was not prepared from ground crumb rubber, but was the by-product powder formed during the shredding process, fallen from the machinery of the plant handling the waste rubber. It could be used as a filler in concrete due to its size.

Details and codes assigned to each type of rubber are given in Table 1 and Fig. 1.
