# Analysis of ancient mortars and design of compatible repair mortars: The case study of Odeion of the archaeological site of Dion

Ioanna Papayianni, Vasiliki Pachta\*, Maria Stefanidou

Lab. of Building Materials, Dept. of Civil Engineering, Aristotle University of Thessaloniki, P.O. Box 482, 54124 Thessaloniki, Greece

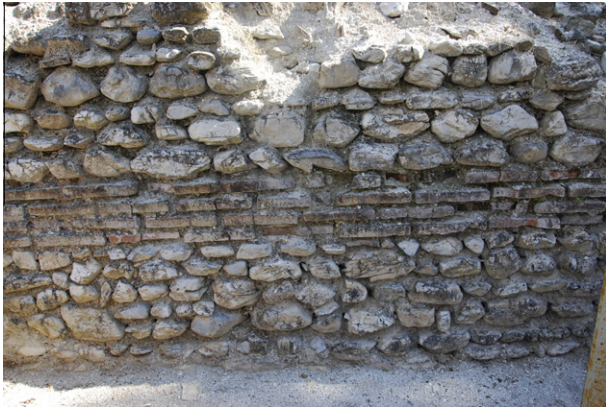
Fig. 1. Masonry type of Odeion (opus-mixtum).

mances and other cultural activities took place [24]. Its ground plan was semi-circular consisting of the orchestra and the auditorium, boxed in an orthogonal perimeter wall (dimensions  $28 \times 19$  m), which formed totally 11 rooms. Masonry walls were built according to the opus-mixtum system, where stone masonry was enriched with zones of bricks (Fig. 1).

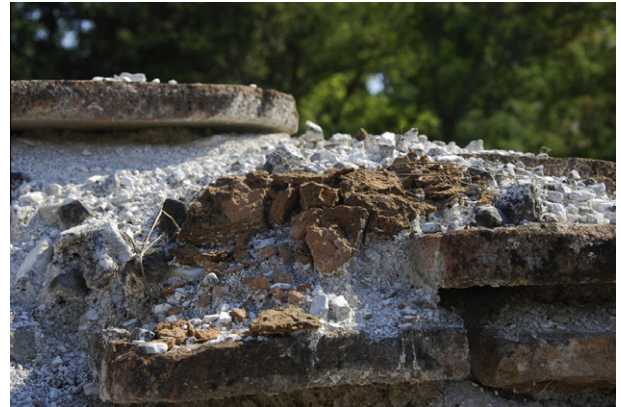
Fig. 3. State of preservation of building materials (mortars, bricks).

The main deteriorating factors of Odeion, as well as of the whole archaeological site of Dion, are the rising humidity and floods, due to the great number of underground and upperground streams and springs on site. Building materials (mortars, stones, bricks) are
