Accidental contamination of a German town's drinking water with sodium hydroxide

Luba Lendowski*, Harald Färber, Andreas Holy, Anke Darius, Bernd Ehrich, Christine Wippermann, Bernd Küfner, Martin Exner

This report describes the cause of the incident and the clinical reactions of those affected by the highly alkaline water.

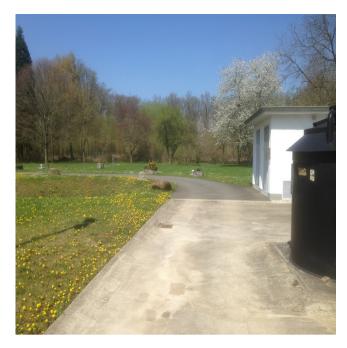
Fig. 1. Exterior view of unmanned pumping station. As can be seen, it sits in a field.

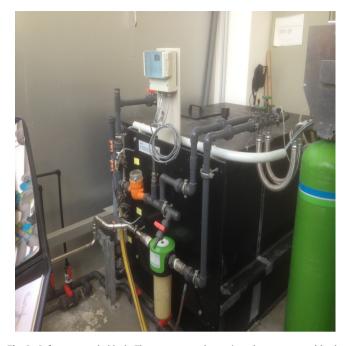
(Bundesministeriums der Justiz und für Verbraucherschutz, 2007). At the pumping station in question soft water held in a 10001 tank is used to dilute the NaOH solution. A pump boosts the soft water and releases it into the drinking water pipe through a dosing lance. The concentrated caustic soda is usually dosed into the suction pipe of this pump.

The investigating expert believes that due to a clogging of the dosing lance the flow of the diluted sodium hydroxide into the drinking water was interrupted. Since the dosing of the concentrated caustic soda was not stopped, the concentrated caustic soda was pumped backwards into the soft water tank and accumulated

Fig. 2. Soft water tank, black. The concentrated caustic soda was pumped backwards into the soft water tank and accumulated there to form a highly concentrated solution.

there and formed a highly concentrated solution. This could have been prevented with a better designed system and state of the art monitoring.

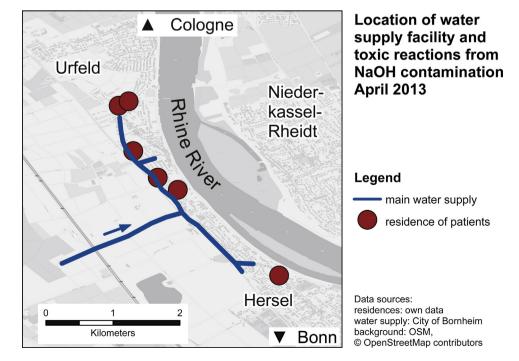
Fig. 3. Blue marked are the streets with contamination and red the reported complaints. (For interpretation of the references to color in this figure legend, the reader is referred to the web version of this article.)
