Dynamic analysis of a bridge repaired by CFRP: Experimental and numerical modelling

The objective of this paper is the structural evaluation of an old three span reinforced concrete bridge in Algeria before and after strengthening by a carbon fibre composite material. The tested bridge is described as well as the instrumentation used. The effect of the composite materials on the modal characteristics of the structure by using ambient excitations testing was quantified.

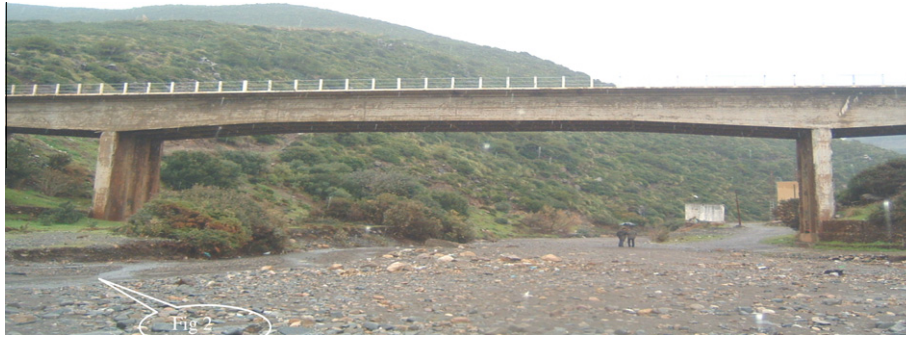
Fig. 1. Overview of the bridge.

The structure is a road bridge crossing Oumazer River located near the old city of Tipaza at about 80 km west of Algiers. The area is situated in a strong seismic activity zone classified as zone III [7]. The bridge is a hyperstatic three span bridge built in 1927. The deck consists of a reinforced concrete slab supported by four reinforced concrete longitudinal beams, while the infrastructure is made up of two piles each made of four posts connected by shear

walls, and two supports (Fig. 1). The geometrical characteristics of the bridge are:

- Total length 70.0 m.
- Length of access span 15.0 m.
- Intermediate span 40.0 m.
- Length of road surface 6.0 m.
- Length of shoulders 1.0 m.
- Height of pile 10.0 m.

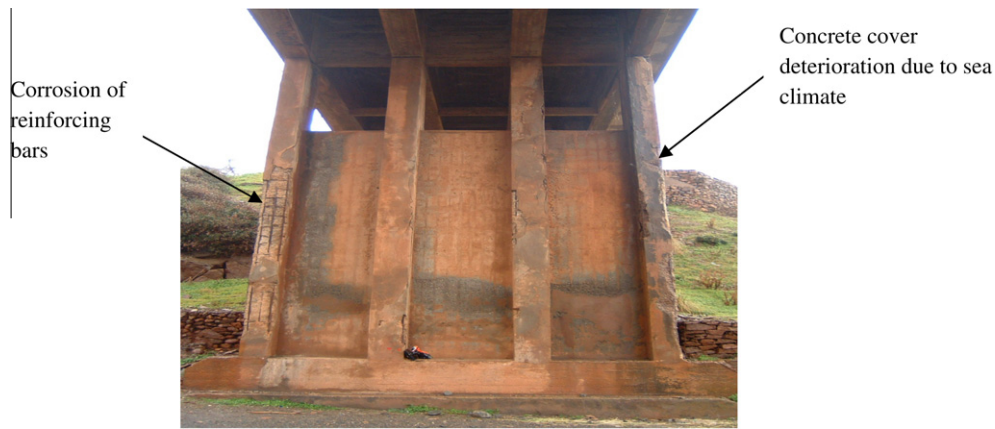
Fig. 2. A view of pile degradations.

The degradations are visible on the bridge structural elements, with cracking in the concrete cover and corrosion of the reinforcement in the beams and piles (Fig. 2). Corrosion of the piles affected the concrete cover with a loss of steel and concrete section probably due to the aggressive marine environment. The diagnosis also reveals cracks inclined at 45° near the support of the main beams indicating an increase in shear stress mainly due to road traffic increase. These damages were probably exacerbated by the
