Shaking table test on the collapse process of a three-story reinforced concrete frame structure

This study explores the collapse process of a reinforced concrete (RC) frame structure subjected to earthquake shakings, by applying the shaking table test on a three-story, one-bay, 1/5-scaled RC structural model. The frame specimen transformed from an elastic state to a highly nonlinear state, then experienced dynamic instability, and finally collapsed to the ground. The structural responses that have been monitored in the presented test include the specimen's dynamic properties, displacements, and accelerations. The data collected from this benchmark test program can be used for the verification of existing analytical and numerical simulation methods, especially for cases involving the large displacement and rotation or collapse process simulation of RC frame structures. It is observed from the test that: (1) the frame survived when the maximum story drift ratio and the residual drift ratio reached 12.51% and 9.60% respectively, indicating that the RC frame structure may have a much high ductility capacity; (2) the collapse of the 1st, 2nd, and 3rd stories was due to failure of the p

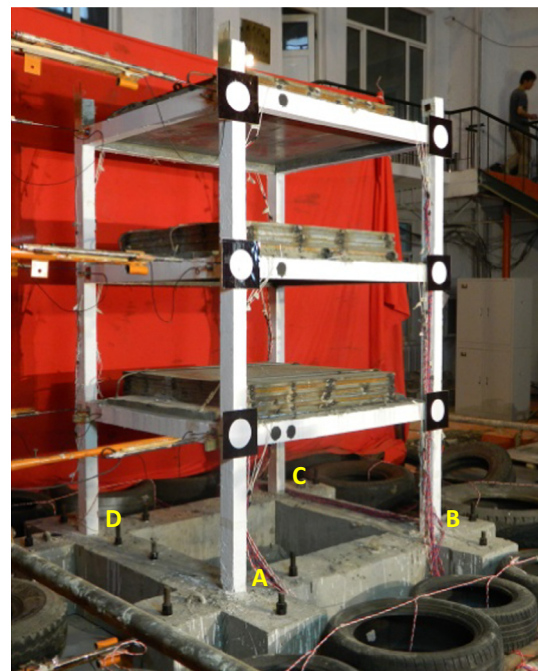
Fig. 1. Geometry of the RC frame specimen.

The test frame specimen was a 1/5-scaled three-story, one-bay, three dimensional RC structure, as shown in Fig. 1. Its corresponding prototype structure was designed according to the current Chinese building codes [32,33]. Fig. 2 shows the specimen geometry and reinforcement details of the test frame specimen. All beams in all three stories were identical (with the same cross-sectional area, length, and reinforcement), as were the columns in all three stories. To minimize the unfavorable effects associated with the out-of-plane movement, the test frame was designed to be symmetric about the two perpendicular axes in the horizontal plane, the column sections were rectangular in shape, and the ground motion was input to the system along the direction perpendicular to the long dimension side of the column section. Additional masses were deployed on the slabs of the 1st, 2nd, and 3rd stories. Traditionally, groups of mass blocks attached to the slabs are utilized as additional masses but these mass blocks may slide and pound with each other when the frame specimen undergoes large deformation; the frame specimen's responses at the collapse stage may thus be altered. To ensure the integrity between the additional masses and the slabs throughout the test, welded layer steel plates (as shown in Fig. 2b) were adopted in this experimental program, instead. The total additional masses, including the steel plates, tie reinforcements, and adhesive mortar (used at the interface between the slab and the steel plate), on the 1st, 2nd, and 3rd stories, were 1197.5 kg, 1197.5 kg, and 726.5 kg, respectively.
