# Fracture behavior of framing coated glass curtain walls under fire conditions

Breaking glass and its subsequent fallout may markedly affect enclosure fire dynamics. However, little is known about the thermal fracture behavior of framing glass façades in different installation forms. Sixteen  $600 \times 600 \times 6 \text{ mm}^3$  solar control coated glass panes, installed in exposed, semi-exposed and hidden frames, were heated by a  $500 \times 500 \text{ mm}^2$  n-heptane pool fire to investigate the influence of frame constraints on glass breakage and fallout. Measurements were taken of the time to breakage occurrence, heat release rates, incident heat flux, central gas temperatures and glass surface temperatures. Measurements in relation to crack initiation and propagation as well as loss of integrity of the glazing assembly were also recorded. The experimental results show that all cracks initiated at the edge of covered sections and intersected rapidly, forming islands. The maximum temperature difference and heat flux that the glass can withstand are primarily in the range of  $50\text{--}90^\circ\text{C}$  and  $9\text{--}15 \text{ kW/m}^2$ . Using the finite element met

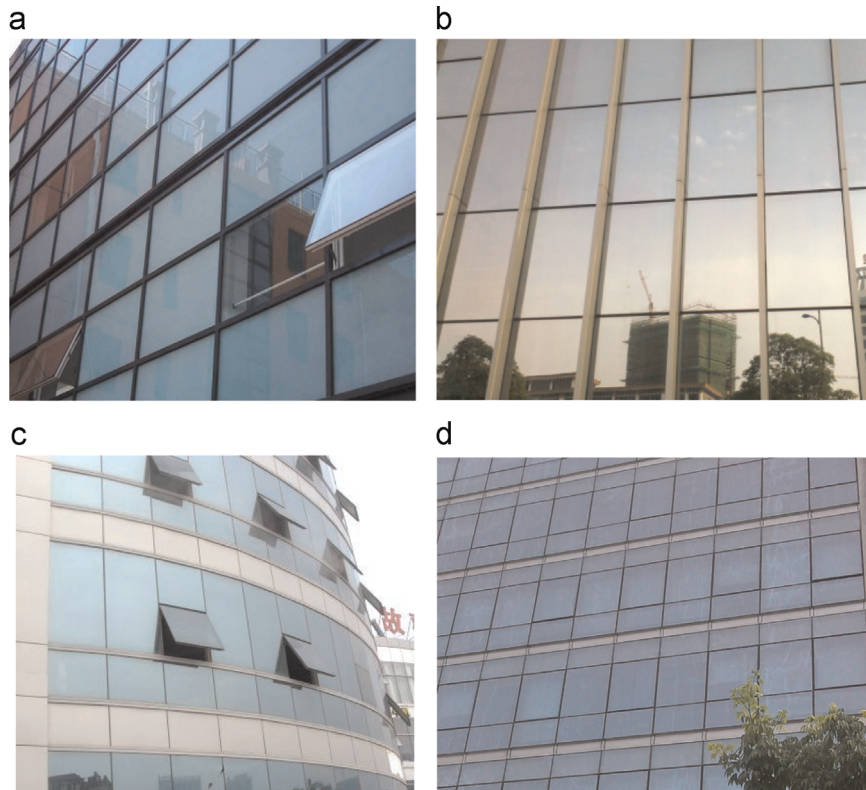
**Fig. 1.** The frame supported glass curtain walls, photographed in four cities in China. (a) Exposed frame, Suzhou; (b) Horizontal-hidden frame, Hefei; (c) Vertical-hidden frame, Huainan and (d) Hidden frame, Shenzhen.

Through an onsite survey in four cities in China, it was found that glass curtain walls employed in engineering primarily can be classified into three types: point supported, frame supported and full glass curtain walls. Among the three types, frame supported curtain walls, in which the glass panel is fixed by a metal frame at its surrounding edges, is used most commonly. Fig. 1 shows the typical frame supported glass curtain walls employed in the four Chinese cities. It can be seen that there are four categories of façades, according to the installation forms: fully exposed, horizontal-hidden, vertical-hidden and fully hidden framing glass curtain walls. The envelope of one building was found to consist of several kinds of framing glass façades, which render the glass
