Fire behaviour of continuous reinforced concrete slabs in a full-scale multi-storey steel-framed building

B. Li^a, Y.-L. Dong^{a,b,*}, D.-S. Zhang^b

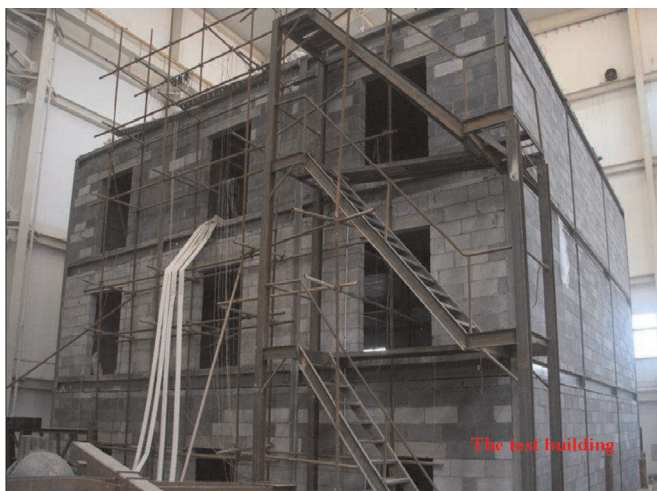
Fig. 1. Picture of the test building.

To further understand the above floor slab systems, a full-scale composite steel frame building with conventional floor slab construction that was representative of a civil architecture style in China, as shown in Fig. 1, was built within a civil engineering laboratory in Shandong Architectural University according to Chinese construction design codes in 2006. Yang [16] and Wang [17] carried out three tests to investigate the structural response of conventional floor systems under fire from 2009 to 2011. The three tests are named Tests 1–3, according to the testing date. Test 1 was a single corner panel test, while Test 2 was a single interior panel test. Both single panel tests were conducted on the top floor of the building [16]. Test 3 was a four (two by two) continuous panel test on the third floor [17]. In Tests 1–2, all the supporting members, including steel beams, columns and beam-to-column connections, were insulated from fire, while in Test 3 only steel-columns and beam-to-column connections were protected from direct fire exposure. The three tests showed a better fire-resisted capacity than isolated tests. The results of Tests 1–3 [16,17] could be concluded as follows:

The full-scale steel-framed building is three stories with the same height of 3.0 m, and each floor contains square areas that are three bays long ($3 \times 4.5 \text{ m}^2$) and three bays wide ($3 \times 4.5 \text{ m}^2$) for a total area of approximately 182 m^2 , as shown in Fig. 1. The floor slabs (120 mm deep) consist of grade 30 normal-weight concrete whose average moisture content is 2.3% by weight measured seven days before the fire test. The test panels are located on the second floor of the building between grid line B–D and 1–4 with an area of approximately 110 m^2 . To easily report the experimental results, the nine panels are labelled as Panels A-I in order, as shown in Fig. 3. All beams are designed to be simply supported as shown in Fig. 2, and they acted compositely with the floor by using

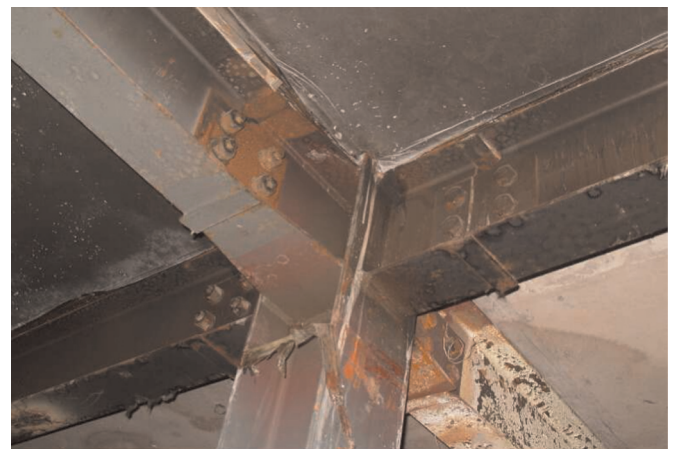
Fig. 2. Picture of the beam-to-column connection.

- The weld-bolted connections, as shown in Fig. 2, behaved better than high-strength bolt connections in terms of effectively releasing stress and preventing the steel beams from local buckling.
