Case Report

Fracture of the proximal extremity of the tibia after anterior cruciate ligament reconstruction: case report[☆]

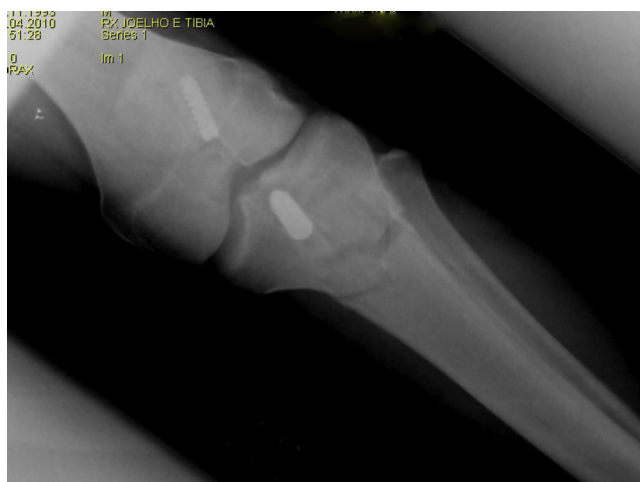
Fig. 1 – Frontal radiograph on knee showing fracture of proximal tibia.

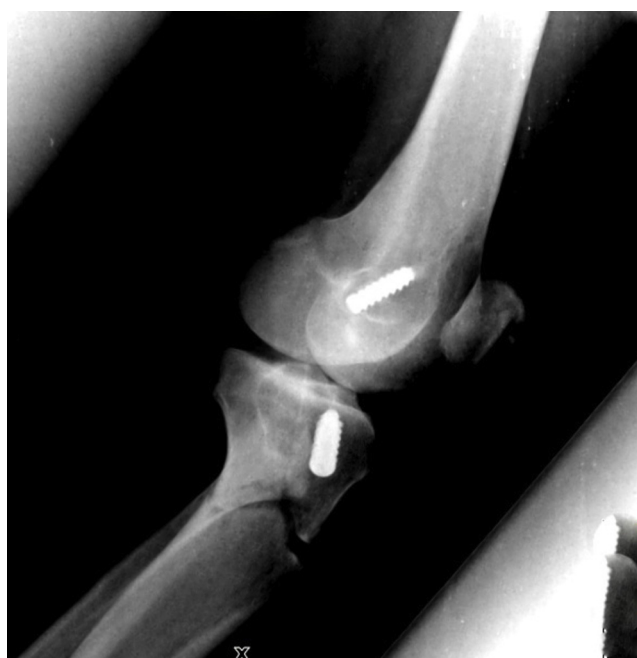
Fig. 2 – Lateral radiograph on knee showing fracture of proximal tibia.

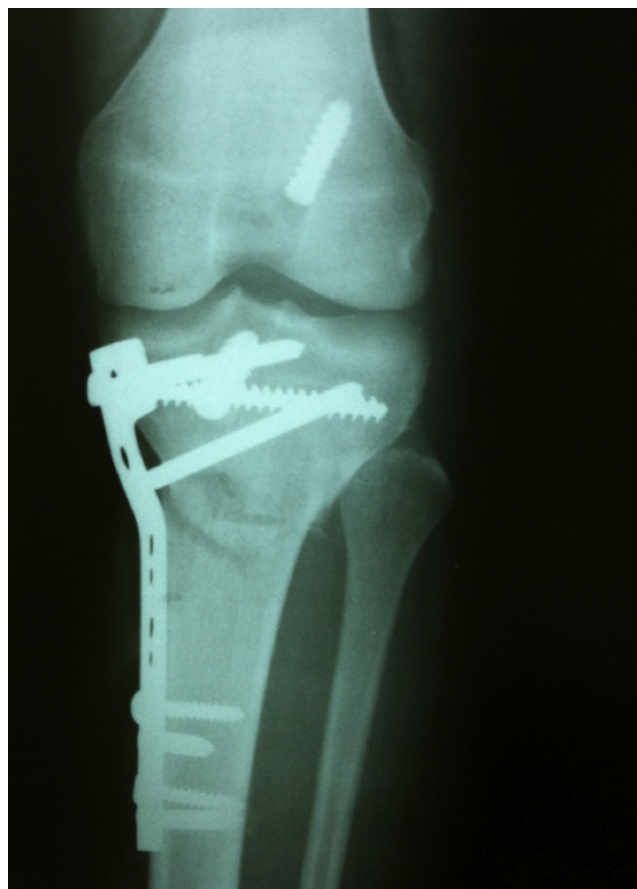
Fig. 3 – Frontal radiograph after operation.
