The Journal of Foot & Ankle Surgery

Vacuum-Assisted Closure in the Management of Degloving Soft Tissue Injury: A Case Report

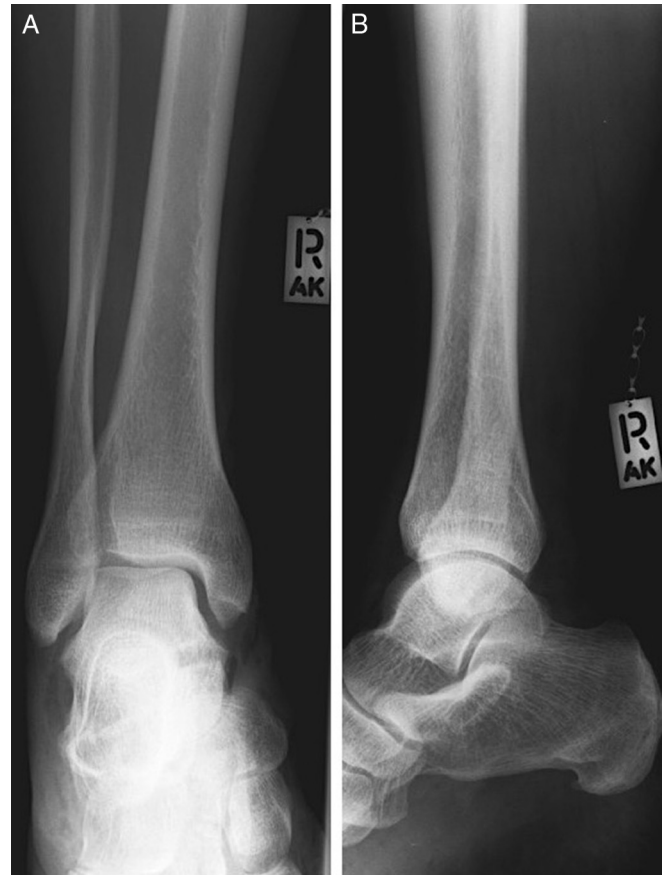
Fig. 2. (A and B) Initial radiographs of the right ankle.

A focused assessment with ultrasonography for trauma scan was performed immediately and did not demonstrate any abnormal findings. A clinical examination showed extensive soft tissue damage in the right foot and a hematoma in the left foot without evidence for associated compartment syndrome in either lower leg. Conventional radiographs of both lower limbs and feet were taken in 2 planes and revealed the absence of bone lesions (Figs. 1 and 2).

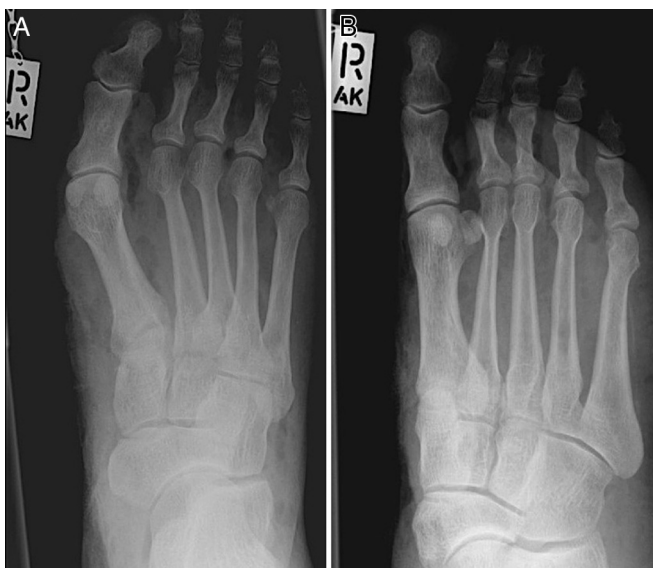
Fig. 1. (A and B) Initial radiographs of the right foot.
