Case Report

Bilateral Second Metatarsal Stress Fractures After Hallux Valgus Correction With the Use of a Tension Wire and Button Fixation System

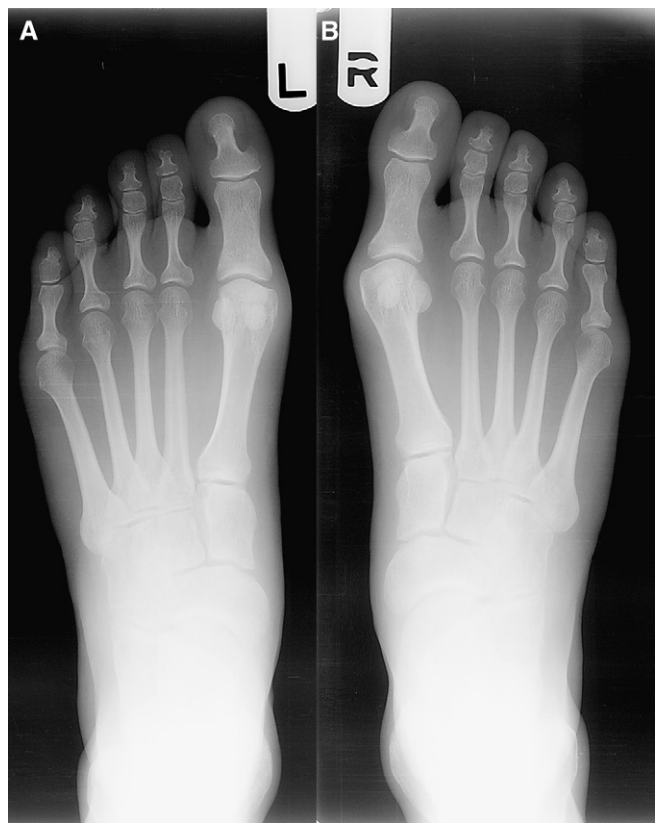
Fig. 1. Preoperative foot radiographs. (A) Left foot, anteroposterior weight-bearing view. The first intermetatarsal angle measures to 10° with a hallux abductus angle of 15.8°. (B) Right foot, anteroposterior weight-bearing view. The first intermetatarsal angle measures to 11° with a hallux abductus angle of 20°.

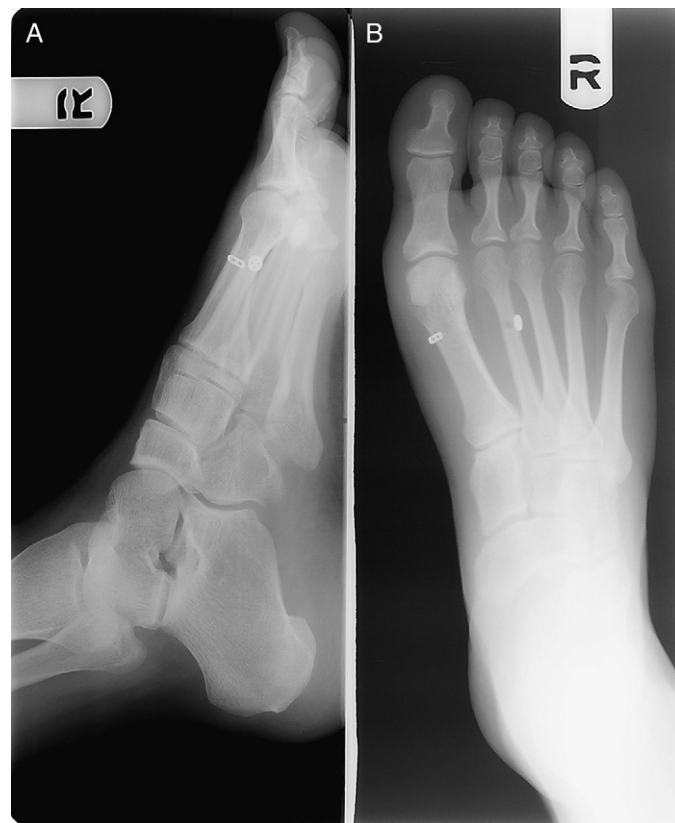
Fig. 2. Six days postoperative radiographs of the right foot. (A) Anteroposterior weight-bearing view. The oblong and round button are well aligned and against the bone. (B) Lateral weight-bearing view. Proper placement of the fixation buttons is confirmed.

Postoperative management consisted of weight bearing in the surgical shoes. The patient progressed without complication until the soft tissues healed and she was allowed to resume the use of regular shoe gear and to gradually increase her weight-bearing activities. Standard radiographs were taken at her first postoperative visit, which was 6 days after the operations (Figures 2 and 3). Reduction of the first IMA was evident in both feet with good alignment of the tension wire and button fixator. There was no evidence of migration of the buttons, and there was no sign of metatarsal fracture in either foot, although there was mild soft tissue swelling observed in each foot over the first and second metatarsals, distally. The patient related no complaints at the time of the 6-day follow-up visit. The patient was
