Abrasion damage of geogrids induced by turbid flow

Ching-Chuan Huang^{*,1}, Chun-Chang Liao

Department of Civil Engineering, National Cheng Kung University, No. 1, Ta-Hsueh Road, Tainan 70101, Taiwan

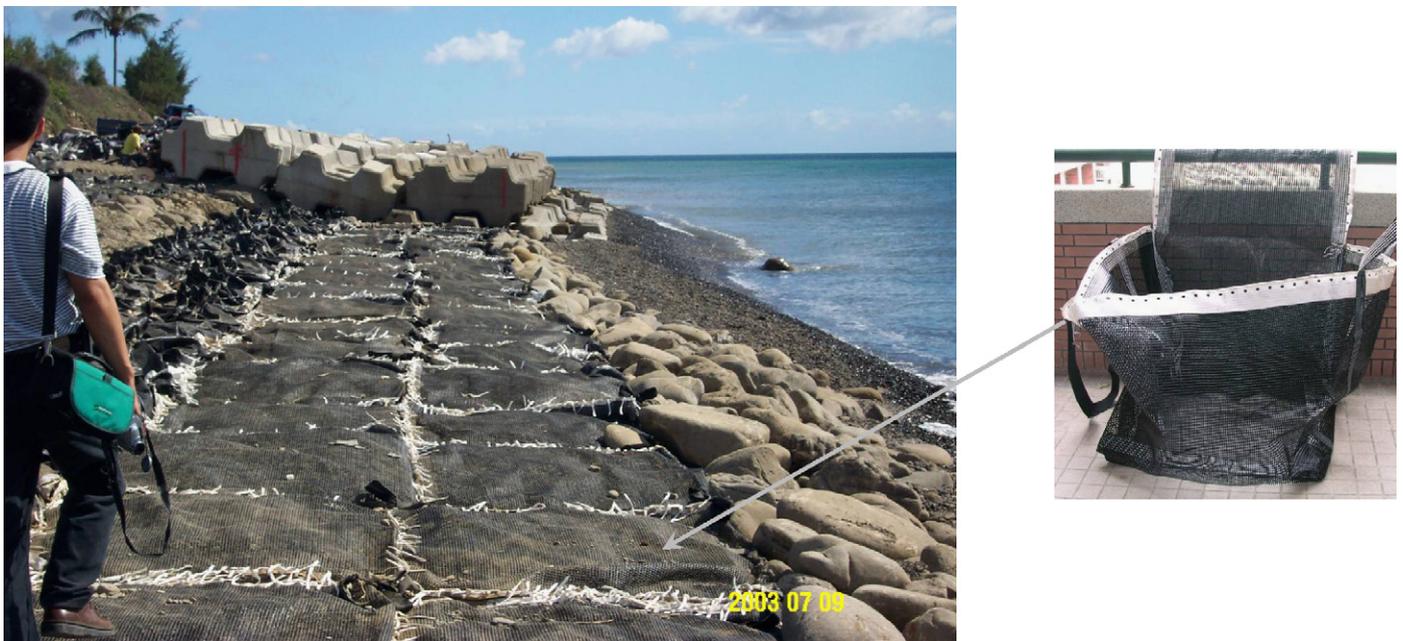
Fig. 1. Geogrid containers used in a pilot test on seashore protection.

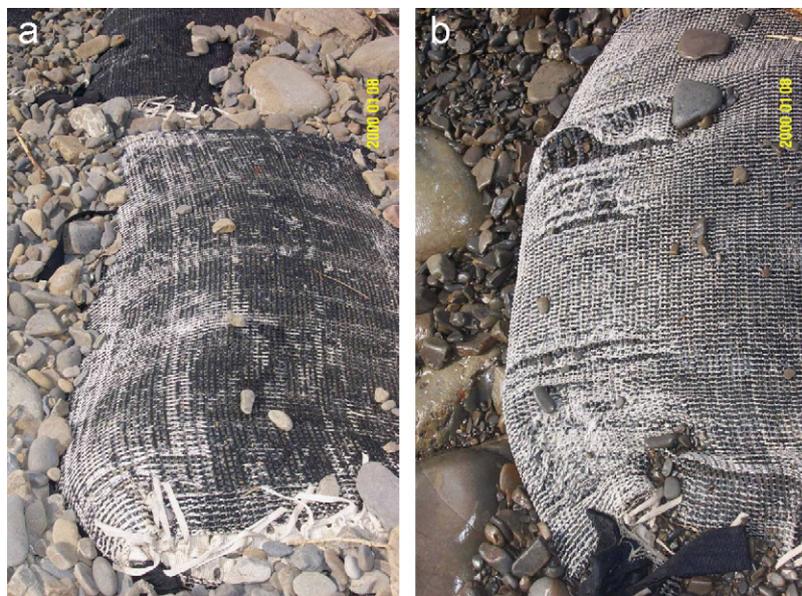
Fig. 2. Various degrees of damage to the geogrid containers observed 1 month after completion: (a) example of moderate damage and (b) example of serious damage.

geogrids has been studied via full-scale trials (e.g. Bush, 1988; Sandri, 1993; Hufenus et al., 2005) and laboratory tests (e.g., Paula et al., 2004; Huang and Chiou, 2006; Huang, 2006). The combined effect of installation damage and creep of damaged geogrids has been investigated (Allen and Bathurst, 1994; Pinho-Lopes et al., 2002), and guidelines for determining reduction factors due to installation damage have also been developed (e.g., Elias, 2001; Hufenus et al., 2005). To the best of knowledge of the writers, no study on the abrasion damage caused by the movement of sands or gravels on the surface of geosynthetics has been performed. Fig. 1 shows a pilot test using geogrid-sewn bags for a gravelly seashore protection. The geogrid bags were made by sewing pieces of high-strength geogrid manufactured from woven polyester (PET) yarns coated with polyvinylchloride (PVC). On-site gravels were used as in-fill material to maximize the effective use of in situ material. One month after placing the gravel-filled geogrid bags, some geogrids facing the sea suffered various degrees of damage (Fig. 2). The possible mechanisms for these damages were visually investigated. Signs of movement of small to large sized gravel particles on the top of
