Numerical modeling of failure mechanisms in phyllite mine slopes in Brazil

This paper presents three case studies comprising failure mechanisms in phyllite mine slopes at Quadrilátero Ferrífero, State of Minas Gerais, Brazil. Numerical modeling techniques were used in this study. Failure mechanisms involving discontinuities sub parallel to the main foliation are very common in these mines. Besides, failure through the rock material has also been observed due to the low strength of phyllites in this site. Results of this work permitted to establish unknown geotechnical parameters which have significant influence in failure processes, like the in situ stress field and the discontinuity stiffness.

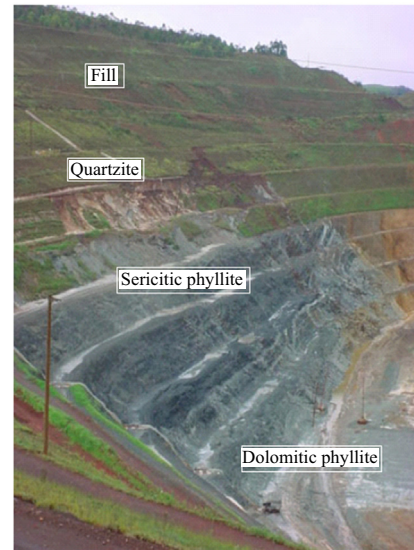
Fig. 2. Partial view of east portion of the slope, in February, 2005 [4].

pit had reached a profundity of 220 m. Fig. 2 displays a partial view of the slope with the position of sericitic phyllite.

Figueiredo and Aquino had presented a previous study of this failure [4]. They used the software Phase 2, Rocscience Inc., in the analyses; their model is displayed in Fig. 3. Many materials were included in that model representing the various lithologies. The lithology directly involved in toppling failure is the Fs (sericitic phyllite). The Fd (dolomitic phyllite) presented large values of displacements during the flexural toppling failure process in the Fs. This lithology is below the Fs (see Figs. 2 and 3).
