## International Journal of Mining Science and Technology

# Failure mechanism of Mesozoic soft rock roadway in Shajihai coal mine and its surrounding rock control

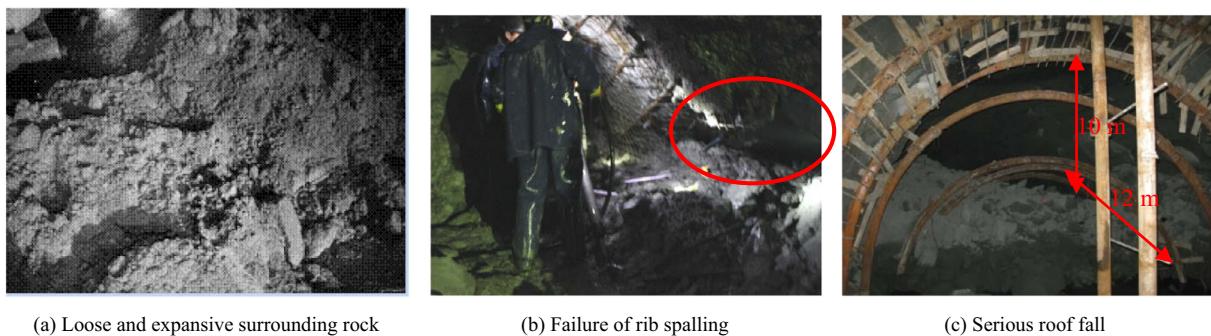
Fig. 1. Deformation and failure of the roadway.

Shajihai coal mine located in the northwest of Junggar Basin coalfield in Xinjiang. The area of mine field is 68.26 km<sup>2</sup>, of which the coal resources reserves are 1.817 billion tons. The coal-bearing strata with the strike of NE-SW, dip of SE, dip angle of 7 to 28° of this mine field mainly include Sangonghe group, Xishanyao group, Toutunhe group of the Jurassic in Mesozoic. The comprehensive development way including two inclined shaft and one vertical shaft is adopted. And the mine is divided into three levels. Currently the first level is developing. During the roadway driving, large deformation destruction problems such as serious roof fall, rib spalling, and bracket failure occurred, as shown in Fig. 1.
