Shear buckling experiments of web panel with pitting and through-thickness corrosion damage

This study considered the shear buckling behavior of a web panel with pitting and through-thickness corrosion damage in the diagonal tension field. Shear loading tests were conducted on three large-scale specimens under different corrosion damage conditions to compare their shear buckling behaviors. To consider corrosion damage, artificial pitting holes and artificial rectangular sectional damage were induced in the lower web panel of each specimen. Finite element (FE) analysis was also performed to evaluate the shear buckling strength and post-shear buckling behavior. From shear buckling test results, the specimen with artificial pitting corrosion damage exhibited similar shear buckling behavior to the specimen without corrosion damage. However, for the shear buckling specimen with artificial rectangular sectional damage, its shear buckling behavior and shear failure mode changed with a slightly distorted diagonal tension band, and its shear buckling strength and critical buckling load significantly decreased relative to the shear buckling specimen with pitting corrosion. Therefore, the re

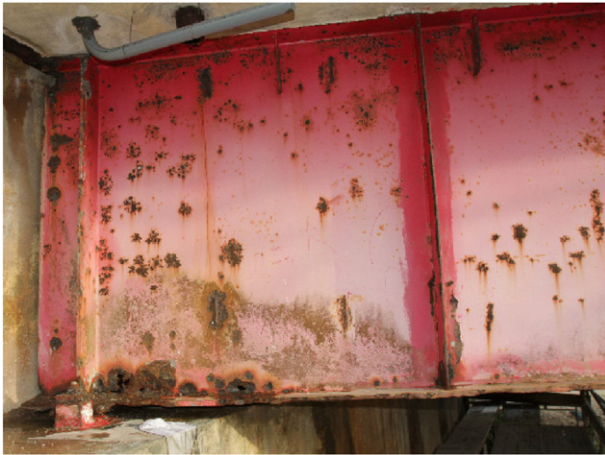
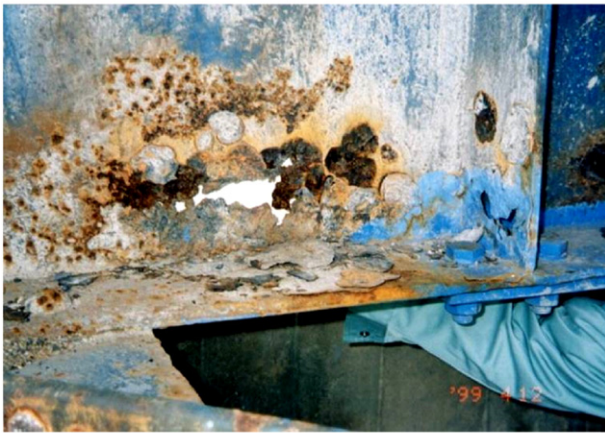
Fig. 1. Pitting corrosion in plate girder bridge.

(a) Pitting corrosion

(b) Through-thickness pitting corrosion [6]

numerically [1–9]. Experiments have been performed to examine the shear buckling behavior of a web panel with local corrosion through shear buckling loading tests, where the thickness of the web panel specimens is reduced to simulate corrosion damage [5]. Numerically, the shear buckling behavior and failure mode of a web panel that is fully corroded longitudinally have been examined under various corrosion and geometric conditions. Numerical analysis has been used to determine the residual shear strength reduction factor of a web panel with local corrosion based on the corroded web volume [6]. To explain the shear buckling resistant area and shear buckling behavior of a web panel with local corrosion, shear buckling has also been analyzed according to the corroded web patterns and web boundary conditions [9]. As similar condition of severe corroded case, shear buckling capacity of plate girders with large web openings was examined [10]. However, these studies considered the local corrosion in the web panel as equivalently corroded thicknesses; they did not consider the changes in the shear buckling strength, behavior, and failure mode due to pitting corrosion. Therefore, this study considered the effects of pitting corrosion and enlarged pitting corrosion on the web panel of shear buckling specimens, as shown in Fig. 1. Their shear buckling behaviors and failure modes were compared with those of a non-corroded web

distributed corrosion pitting web panel on the shear buckling behavior, as shown in Fig. 1(a). In the through-thickness corrosion specimen (ER-H100), a rectangular piece of the web was removed from the tension field of the web panel, which resists the shear buckling load, to simulate the severe corrosion damage induced by pitting corrosion, as shown in Fig. 1(b). The shear buckling loading test specimens with pitting corrosion and through-thickness corrosion damage were as follows:
