Case Report

Removal of the broken part of implantable cardioverter-defibrillator's electrode causing pulmonary embolism via femoral vein

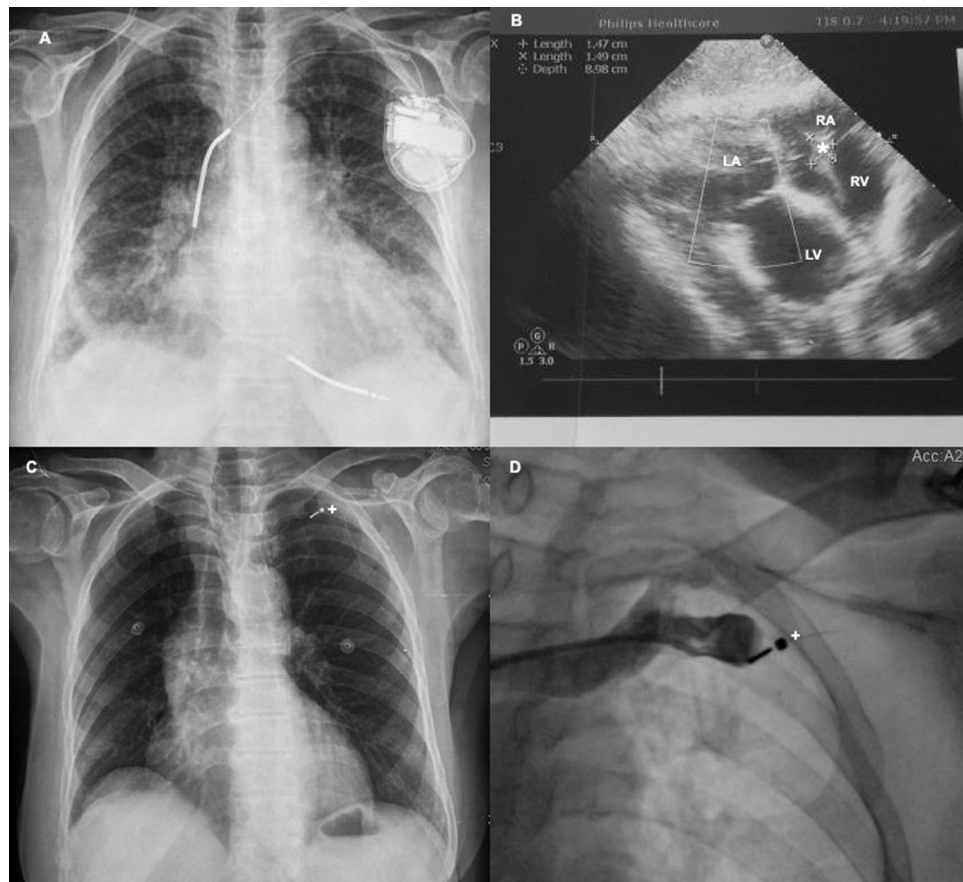
Fig. 1 – Chest X-ray image in the usual ICD (A), echocardiographic image of vegetation on the electrode (B), chest X-ray image in the regular electrode fragment (C), and left subclavian venography preventing passage opaque appearance as electrode fragment (D). RA, right atrium; RV, right ventricle; LA, the left atrium; LV, left ventricle; *, vegetation with thrombus; +, an electrode fragment.

obstetrics and gynecology clinic. As viewed by the chest X-ray, placement of ICD and electrode was normal (Fig. 1A). On the transthoracic echocardiography (TTE), there was endocarditis vegetation with dimensions of 1.5 cm × 2 cm on electrocatheter leads, especially in the level of the tricuspid valve (Fig. 1B). Subsequently, the patient was taken to intensive care unit with a diagnosis of infective endocarditis. Antibiotherapy was started. During the follow-up period, blood cultures were taken; however, there were no reproductions of microorganisms. After a week, there was no improvement in clinical situation of patient, and vegetation size did not change on TTE. Therefore, the patient underwent the transvenous extraction of whole system. Lead body dwelling time is 21 months. Currently, three different techniques have been used for electrode extraction: surgical extraction, percutaneous extraction by a superior approach, or percutaneous extraction by an inferior approach. Percutaneous extraction by superior approach procedure was performed with fluoroscopy in the catheterization laboratory. First, ICD battery was extracted. However, the distal part of the electrode was broken during manual traction through the left subclavian vein. Distal broken electrode fragment was left in the subclavian vein (Fig. 1C). Left subclavian venography revealed a broken electrode fragment

and thrombus formation, which was placed in the mid-subclavian vein (Fig. 1D, Video 1). Then, it was decided to extract the broken electrode fragment through the femoral approach. The broken electrode fragment was captured in subclavian vein with 25 mm snare (Amplatzer GooseNeck Snare, Covidien Co, MN, USA). The captured electrode fragment was embolized to the left pulmonary artery at the level of the right atrium (Fig. 2A). Pulmonary angiography showed embolized electrode fragment in branches of the left pulmonary artery and was captured once again by the help of the snare (Fig. 2B, Video 2). While the electrode fragment was pulling back at the level of the main pulmonary artery, it was fled to the right branch of pulmonary artery over again (Fig. 2C, Video 3). The broken electrode fragment was captured again with the snare in the right branch of pulmonary artery and was drawn up to the femoral vein. It was pulled to the right femoral vein. The fragment was greater than sheath diameter, and to avoid dissecting the scar tissue about the lead, it was removed by exploration of the femoral vein; afterwards, femoral vein was closed by cardiovascular surgery using primary suture with local anesthesia in the operating room. The broken electrode fragment was removed successfully and there were no residual fragments (Fig. 2D).
