## Chinese Journal of Traumatology

#### Original article

## Multi-slice computed tomography for diagnosis of combined thoracoabdominal injury

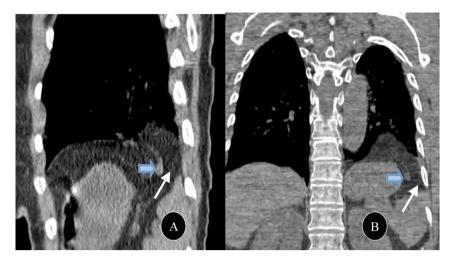
Fig. 1. Sagittal (A) and coronal (B) reformatted CT images show that left diaphragm rupture is revealed by the segmental diaphragmatic defect sign and dangling diaphragm sign. The omentum has herniated into the thorax through the diaphragmatic defect. Abdominal fat is located above the diaphragm and positioned against the posterior thoracic wall.

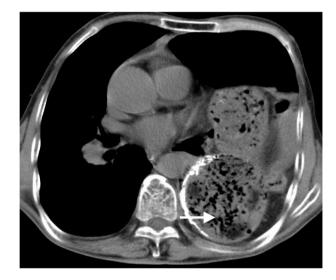
Fig. 3. Axial CT image shows the stomach is in a dependent position along the posterior left ribs and contacted the posterior thoracic wall (dependent viscera sign).

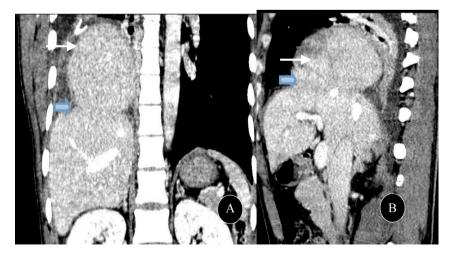
Fig. 2. Coronal (A) and sagittal (B) contrast-enhanced reformatted CT images show right-sided diaphragm rupture, part of the liver herniated into the thorax through a small diaphragmatic defect, which is evident from the focal constriction of herniated liver called "collar".
