Experimental and numerical evaluation of the impact of folds on the pressure rating of CIPP liners

A. Jaganathan ^{a,1}, E. Allouche ^{a,*}, M. Baumert ^{b,2}

^a Trenchless Technology Center, Ruston, LA, USA

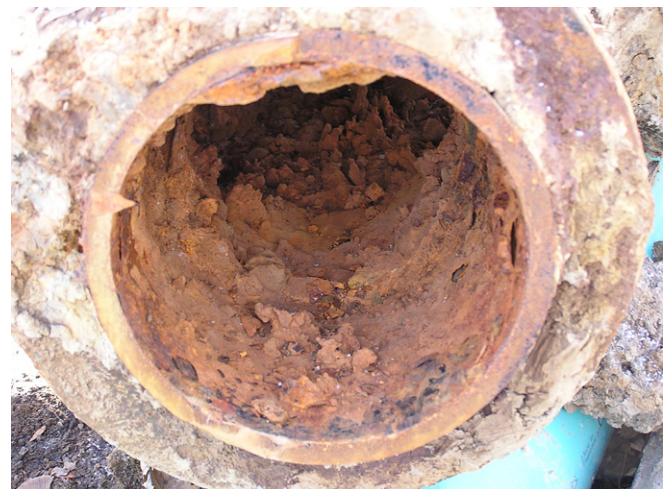
Fig. 1. A typical corroded water main from the City of Hamilton.

Samples used in this study were collected from a trial relining project in the City of Hamilton, Ont., Canada. A 1000 m long section of a 70 year old 152 mm (6 in.) internal diameter and 12 mm (0.43 in.) thick grey cast-iron water main (Fig. 1), which exhibited approximately two breaks per winter over a five year period, was lined with a fiber-reinforced CIPP liner. The operational water pressure in this part of the city is 340–410 kPa (50–60 psi) with periodical surges to 550–750 kPa (80–110 psi), which are believed to last 10–12 s. Following installation, excavations were performed at a number of locations along the alignment, and short sections (1.2 m each) of the lined cast-iron water main were exhumed for testing and evaluation purposes. It was noticed that many of the samples collected had continuous 'folds' running along the pipe's longitudinal axis (Fig. 2). The folds were continuous, running along the entire length of the samples. In many cases, the void created by the fold had little or no resin in it. The CIPP liner used in this water main was a three component system consisting of an elastomer skin, a jacket and an adhesive. The jacket was a woven textile fabric (polyester) reinforced with glass fibers. Fig. 3 shows a section of an uncured liner (jacket with an elastomer skin). Coupons (dog-bone shaped specimens) were cut from the samples and subjected to uniaxial tensile tests on an MTS multi-purpose testing machine. The tests were done in accordance with ASTM 638 (ASTM, 2000). Data from the tensile test was plotted to derive material parameters. Curves plotted using engineering stress–strain values as well as true stress–strain values are shown in Fig. 4. As suggested in ASTM F 2207-02,
