## Short communication

## Accidental ingestion of fractured part of a pendulum appliance

**Purpose:** How to deal and the precautions to be taken to avoid any injury from accidental ingestion of an appliance or a part of an orthodontic appliance during a chair-side procedure or later Case History Patient ingested a foreign body (wire) of orthodontic (pendulum appliance) origin.

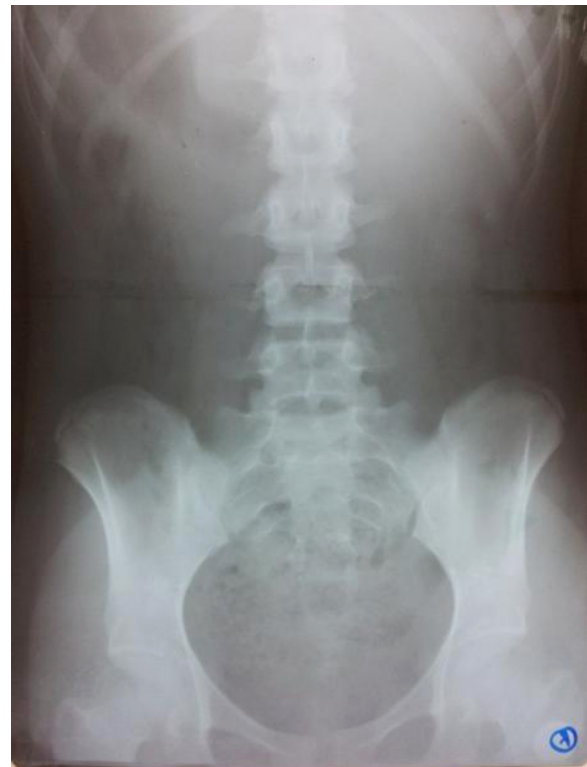
Fig. 3 – AP view erect abdomen after 3 days.

the AP view of erect abdomen was repeated after 3 days (Fig. 3). On viewing the radiograph there was a clear view suggesting there was no wire and that it was excreted out as expected (Fig. 4).
