Clinical case

Vertical root fracture diagnosis of crowned premolars with root canal treatment – Two case reports

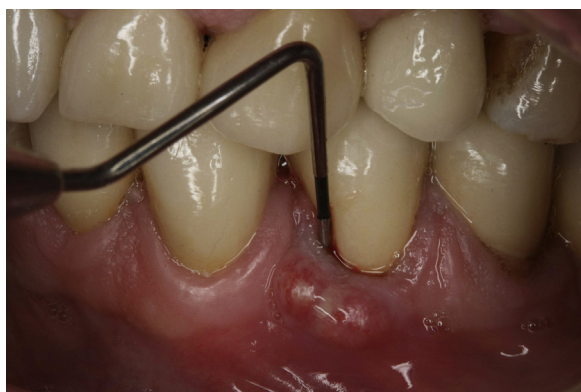
A 55-year-old male presented to an endodontic evaluation of tooth 34 (mandible first left premolar) and tooth 44 (mandible first right premolar). Heavy bruxism was diagnosed in the dental medical history. The patient confirms that he rarely uses his night mouthguard. The endodontic therapies were performed two years before as part of an oral rehabilitation plan following the quality guidelines of the European Society of Endodontology⁷. Tooth 34 had a cervical located fistula and gingival swelling. The tooth had tenderness to percussion and palpation and had a buccally located periodontal pocket of 7 mm (Fig. 1) surrounded by normal periodontal depths of 3 mm. A similar defect was present on the lingual

Fig. 1 – Figure showing probing periodontal pocket on the buccal aspect of the tooth 34. Note the presence of swelling and fistula.

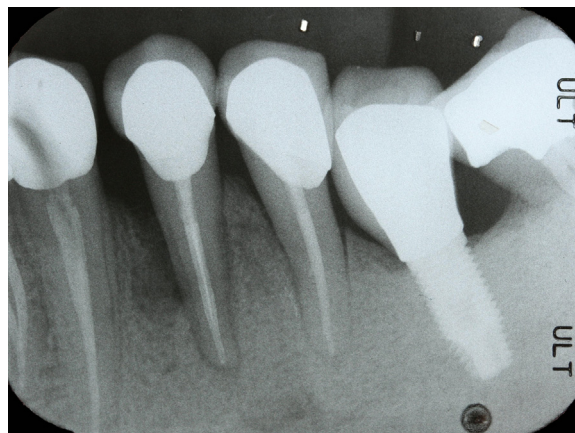
Fig. 2 – Periapical radiograph showing vertical bone loss on the mesial region of the tooth 34.

periodontal region of the same tooth. A radiograph analysis was able to show a vertical bone loss of the mesial face to the root (Fig. 2). Based on the symptoms, clinical and radiographic signs a diagnosis of vertical root fracture was concluded. Extraction of tooth 34 was proposed and accepted. After the extraction it was possible to visualize the fracture lines (Fig. 3).
