# Torsional Failure Characteristics of a NiTi file based on a Case Report

Jorge N. R. Martins\*; Joseph DiBernardo\*\*

(Martins JNR, DiBernardo J. Torsional Failure Characteristics of a NiTi file based on a Case Report. Rev Port Estomatol Med Dent Cir Maxilofac 2010;51:85-89)

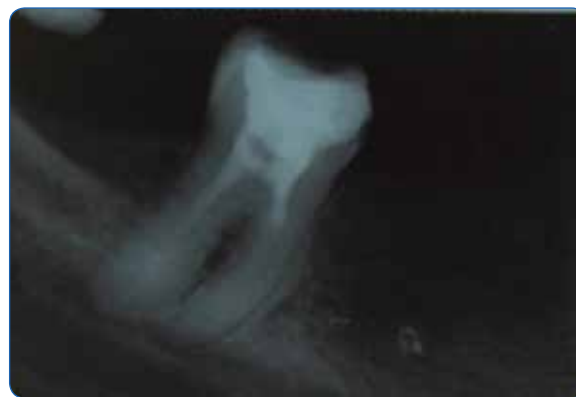
**Figure 1** - A diagnostic radiograph. The Prosthodontic clinic requested an improvement of the root canal treatment for a better prognosis.

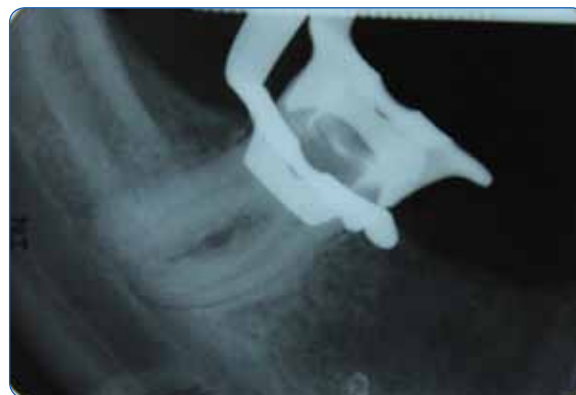
**Figure 2** - Radiographic image of a separated ProTaper S1 file on the mesial buccal canal.

Coronal enlargement was first performed with a ProTaper SX file (Tulsa Dental, Tulsa OK) and then a brand new ProTaper S1 (Tulsa Dental, Tulsa OK) rotary file was used to achieve the working length. The instruments were used with a Tulsa Dental Motor (Tulsa OK) at a medium torque setting and a speed of 300 RPM. An instrument separation occurred during this phase of cleaning and shaping (Figure 2). The by-pass option was attempted and was successful. The treatment was concluded in three appointments, with the use of calcium hydroxide as intracanal medication between the appointments. The objective requested by the oral rehabilitation team, the improvement of the quality of the original root therapy procedure, was achieved (Figure 3).

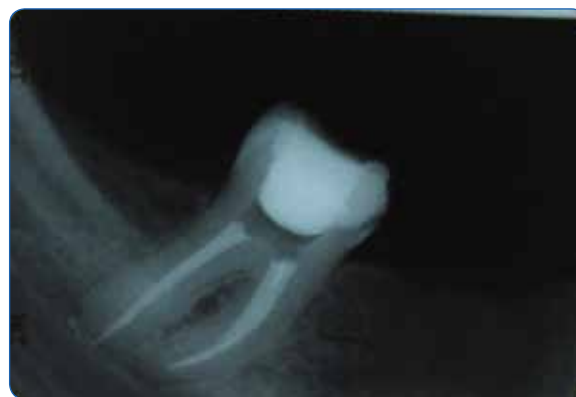
**Figure 3** - The final radiograph. The separated file was by-passed and the request of Prostodontic department was achieved.
