Case Report

34-week follow-up of suture anchor fixation for a traumatic patellar fracture overlying a total knee arthroplasty

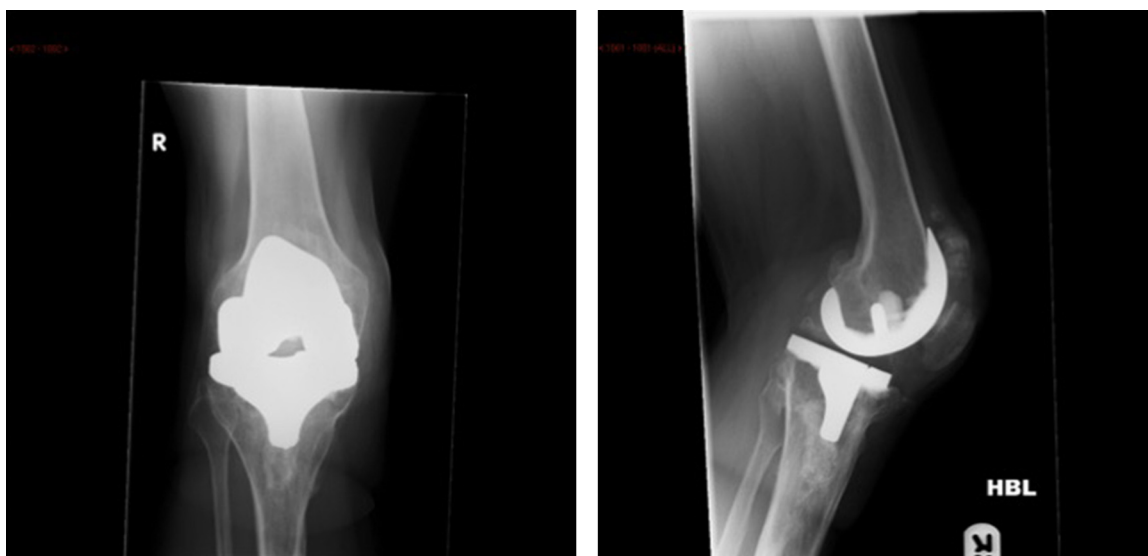
Fig. 1 – Anteroposterior and lateral radiographs of the right knee, showing a comminuted periprosthetic patellar fracture.

Three years postoperatively, the patient was brought in by ambulance to the Emergency Department with a right knee injury. The patient described falling heavily onto her right knee, with a subsequent inability to weight bear. Physical examination revealed significant anterior right knee swelling, with no external wound. The knee was diffusely tender, particularly on palpation of the patella, and assessment of range of movement (including extension and straight-leg raise) was severely limited by pain. There was no distal neurovascular deficit. Anteroposterior and lateral radiographs were performed and are shown in [Fig. 1](#).

Anteroposterior and lateral radiographs demonstrated a comminuted fracture (consisting of 3 main fragments and multiple small fragments) of the proximal pole of the right patella, displaced from the distal portion by 20 mm at

maximum separation. No other fractures were identified and there was no evidence of loosening of the total knee prosthesis. The patient was placed into a knee extension splint and admitted to hospital for further management.

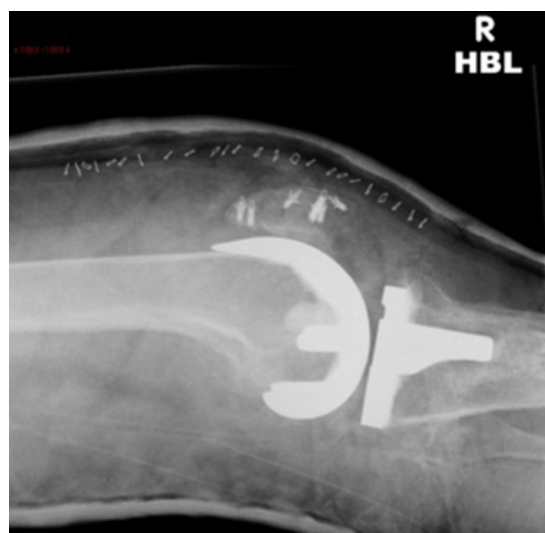
Fig. 2 – Postoperative lateral radiograph of the right knee, following suture anchor fixation.

On the basis of the radiological and intraoperative findings, the fracture was deemed to be unreconstructible using a tension-band or cerclage wiring. Thus, 3 suture anchors (G-II QuickAnchor Plus; DePuy Mitek Inc., Raynham, Massachusetts, USA) were introduced into the distal patellar fragment, and one suture was introduced into the largest of the fracture fragments. A further 2 sutures were also introduced into the largest fragments of the superior pole of the patella. Using a 2.5 mm drill, holes were bored into adjacent fracture fragments to receive threads from the suture anchors. With the knee in extension, the fragments were reduced to the intact distal patellar fragment using bony reduction forceps, before each pair of suture threads were tied together to encircle the related fracture fragment. After wound closure and dressing in the standard fashion, the patient's knee was placed into a cylindrical plaster of Paris cast. Postoperative radiographs are shown in Fig. 2.
