## Root repair and regeneration after miniscrew root damage

**Background:** Root damage due to miniscrews can be a potentially serious complication. This case report describes a 21-year-old woman with bimaxillary protrusion and a congenitally missing mandibular left lateral tooth. Miniscrews were placed mesial to the maxillary second premolars.

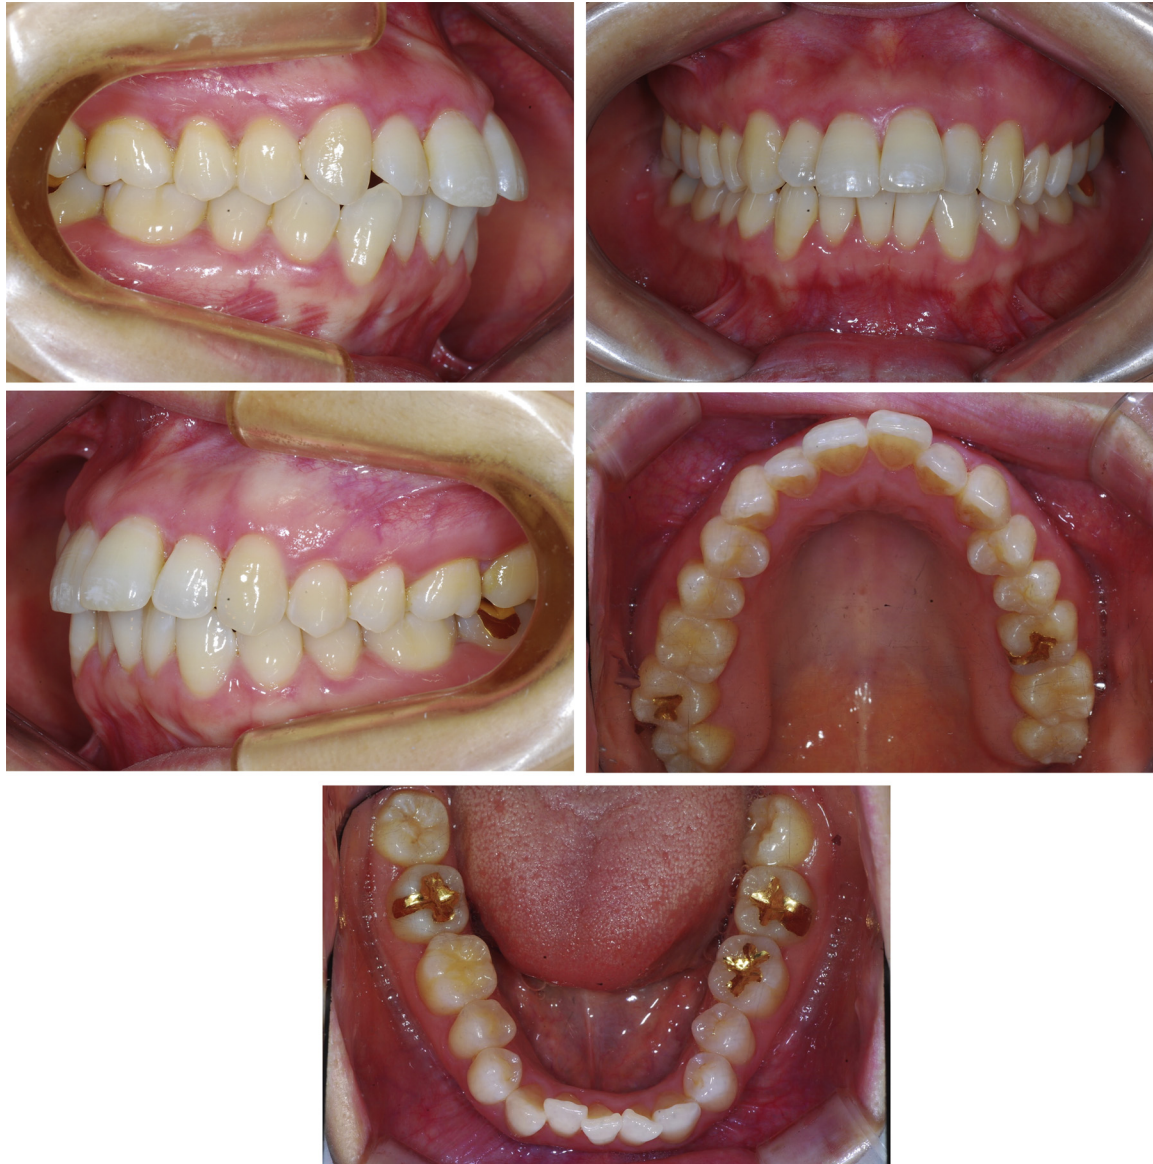
**Fig. 1.** Despite the Class I molar relationship, there was anterior crowding in the mandibular and maxillary arch. The midline was shifted to the left due to a congenitally missing mandibular left premolar.

A 21.6-year-old female patient presented with a chief complaint of lip protrusion. The treatment plan involved retraction of the anterior teeth after extraction of all first premolars except for the left mandibular first premolar (Fig. 1). Miniscrews were placed mesial to each maxillary second molar to preserve anchorage. Additional miniscrews were planned to be placed mesial and apical to the left maxillary second premolars for simultaneous retraction and intrusion of the maxillary anterior teeth (Fig. 2).
