Post-Vertebral Augmentation Spine Imaging

Sudhir Kathuria, MD

Neuroimag Clin N Am 24 (2014) 337–347
<http://dx.doi.org/10.1016/j.nic.2014.01.007>

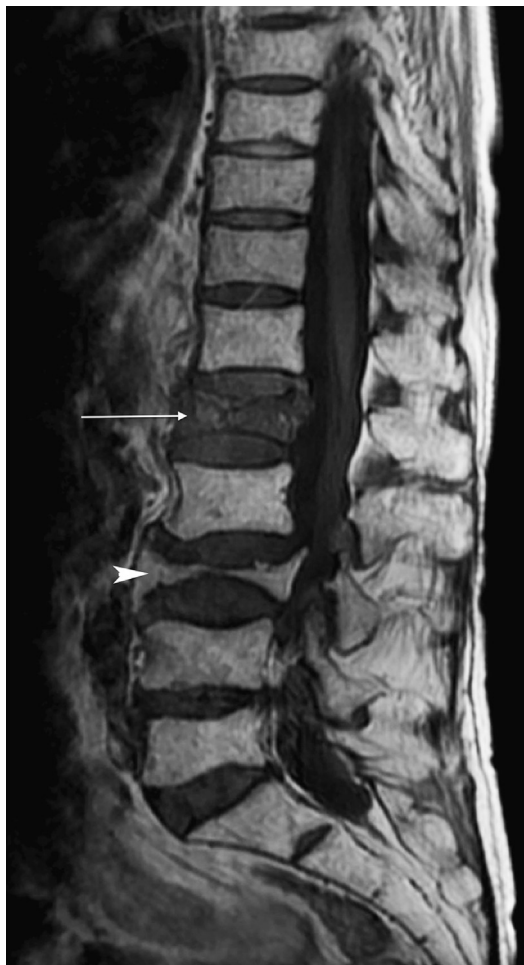
Fig. 1. T1-weighted magnetic resonance (MR) image shows the acute nature of L1 vertebral compression fracture by demonstrating edema as low signal intensity (arrow). Compare this with the L3 vertebral compression fracture with no edema, suggesting its chronic nature (arrowhead). Only the L1 level was treated with vertebral augmentation (VA), with complete resolution of the patient's symptoms of back pain.

The usefulness of cross-sectional imaging in preprocedure evaluation of a VA procedure, including MR imaging and CT, is well established.⁴ MR imaging provides information on anatomic vertebral collapse and marrow edema that is essential for identifying the location and extent of the disease (Fig. 1). It also provides useful information about any canal or neural compromise. CT is helpful in identifying the potential route of cement extravasations by demonstrating any open fracture lines and osseous destruction, especially in pathologic fractures.⁵
