Case Report

Intra-articular Protrusion of Malpositioned Transfix Implant Following Anterior Cruciate Ligament Reconstruction

Abstract: We report on a case of stiffness of the knee following reconstruction of the anterior cruciate ligament caused by a Transfix implant (Arthrex, Naples, FL) protruding into the medial retinacular area. After a skiing injury, a 56-year-old woman had a complete rupture of the anterior cruciate ligament along with a tear of the medial collateral ligament. She had an immediate anterior cruciate ligament reconstruction. A hinged brace was put on postoperatively. She presented to this institution 2 months after surgery with pain, stiffness, and decreased range of motion. Magnetic resonance imaging showed protrusion of the bioabsorbable implant in the medial retinacular area. Scar tissue was seen around the tip of the implant, medial retinacular area, and in the medial gutter. The terminal end of the protruding screw and the excess of scar tissue were removed arthroscopically. At the end of surgery, her on-table range of motion of the knee was 0° to 120°. She recovered well after physiotherapy and at the 3-month follow-up she was pain free and had virtuall

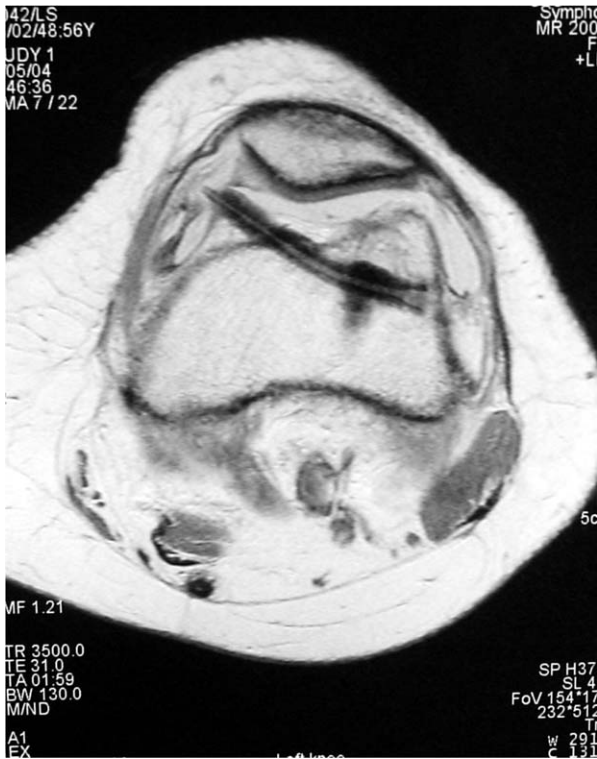
MRI scans of the knee showed a rather anterior Transfix implant (Arthrex, Naples, FL) in the femur. The tip of the implant was intra-articular and protruding into the medial retinacular area as seen on axial cuts (Fig 1). Scar tissue was seen in the medial retinacular area around the tip of the screw and extending into the medial gutter.

FIGURE 1. Axial cut MRI scan showing protrusion of the Transfix implant into the medial retinacular area of the knee joint.

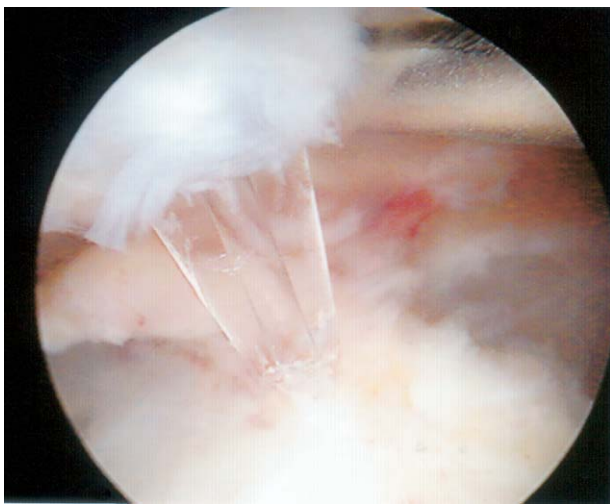
FIGURE 2. Protruding part of the Transfix implant as viewed arthroscopically.

Arthroscopy was performed and the terminal end of the bioabsorbable Transfix device (Fig 2) was cut off and retrieved from the joint using a rongeur (Fig 3). The end of the screw was smoothed and made flush

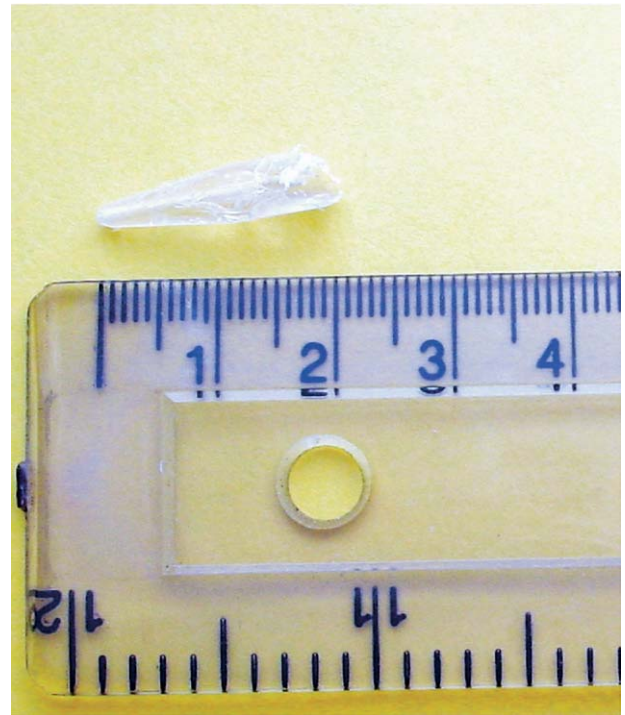
FIGURE 3. Terminal part of implant, removed arthroscopically

with the bone using a burr. Extensive scar tissue was shaved from the suprapatellar pouch and the medial retinacular area (Fig 4). The patient's on-table range of motion was 0° to 120°. She recovered well and attended physiotherapy postoperatively. At the 3-month follow-up, her range of motion improved to almost full flexion and the pain had decreased considerably.

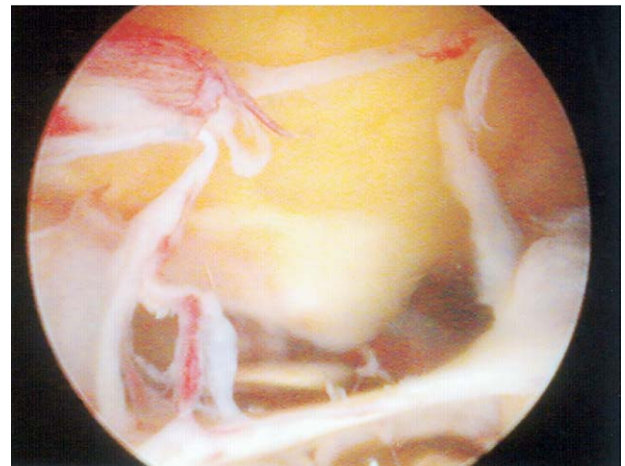
FIGURE 4. Arthrofibrosis in the suprapatellar area.
