## Trauma Case Reports

### Case Report

# Osteochondral autograft transfer for post-traumatic osteochondral defects of the anterolateral surface of the distal tibial plafond

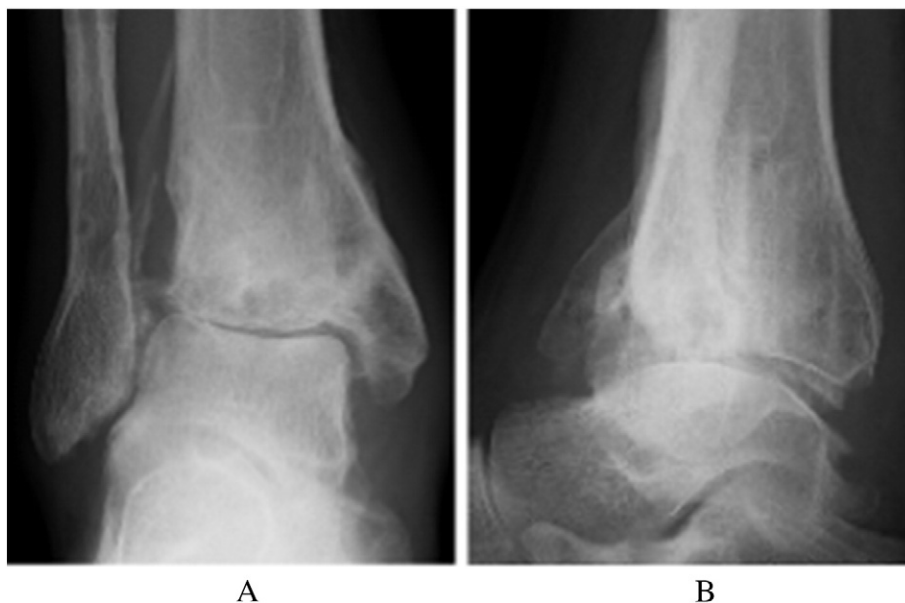
**Fig. 1.** Radiographs at the initial examination showed an osteophyte in the anterolateral corner of the right plafond and moderate narrowing of the ankle joint. Forward displacement of the talus was seen: (A) anteroposterior view, (B) lateral view.

The AOFAS ankle score at that point in time was 50 [1]. Radiographs showed moderate narrowing of the ankle joint and forward displacement of the talus (Fig. 1-A, B). Computed tomography of the right ankle showed an osteochondral defect on the anterolateral surface of the distal tibial plafond (Fig. 2). This was diagnosed as progressive osteoarthritis caused by an osteochondral defect on the anterolateral surface of the distal tibial plafond, and surgical repair of the osteochondral defect was recommended. Three months later, the osteochondral graft was performed on the patient's right ankle. The patient was placed in the supine position under general anesthesia. The lower extremity was prepared and draped in the standard sterile fashion. We inserted the 2.0 mm K-wire in his right calcaneus, then skeletal traction was done in order to open his right ankle joint space if necessary. Next, 10 mL of fluid was injected intra-articularly to distend the ankle. The anterolateral ankle arthroscopy portal was established in the routine fashion, and global
