Sorption properties of historic and recent pine wood

Valery Kozlov^a, Margarita Kisternaya^{b,*}

ABSTRACT

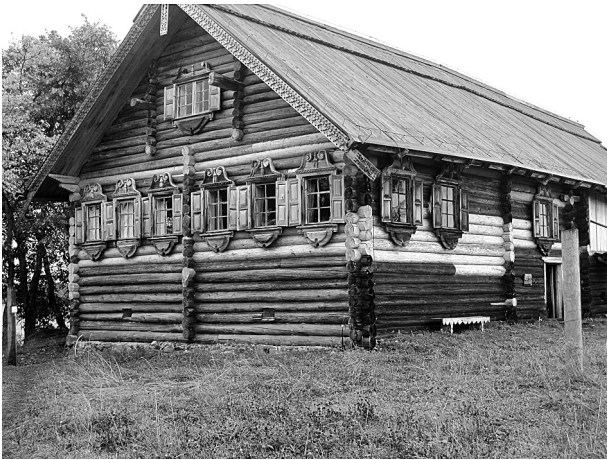
Fig. 1. Numerous new patches influenced the aesthetic appearance of the house of peasant Sergeev from the Village of Logmoruchei (1910), Kizhi Open-air Museum, Russia.

Introduction of new material reduces the aesthetic appreciation of the monument (Fig. 1). There is an opinion that new material can be easily degraded by wood-destroying fungi from infected historic timber (Gorshin et al., 1992). It can also cause additional deformation due to uneven shrinkage of fresh material.
