The role of riparian trees in maintaining riverbank stability: A review of Australian experience and practice

T.C.T. Hubble^{a,*}, B.B. Docker^a, I.D. Rutherford^b

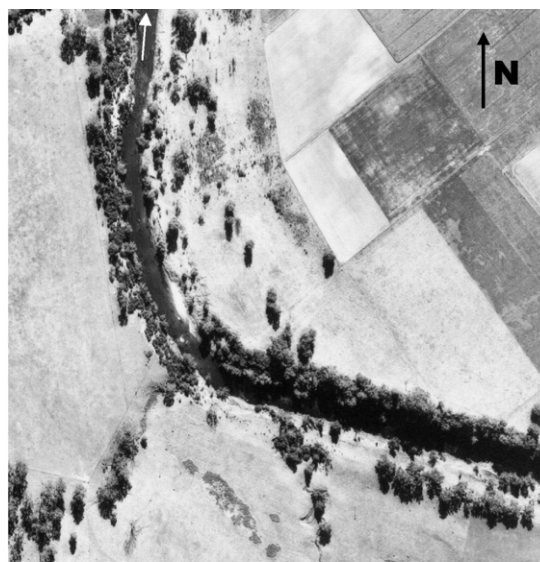
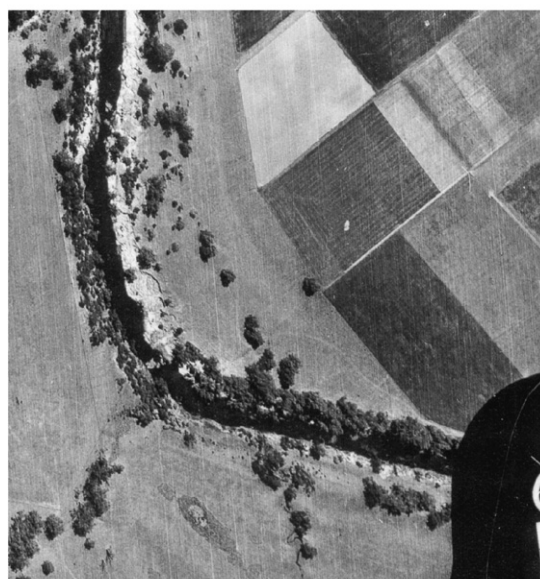
Eagle Creek Bend, Upper Nepean River 1961

Fig. 2. Aerial photographs of the Nepean River taken in 1961 and 1965; downstream flow is indicated by an arrow, and is towards the top of the page. Comparison of the images indicates prominent bank failure features developed on the previously devegetated right-hand bank which is on the inside of the meander bend. This contrasts with the absence of bank failure features on the vegetated left-hand bank located on the outside of the meander bend. This contrast in behaviour was demonstrated to be due to the absence of root-reinforcement of the bank soils (right bank) by Hubble (2003, see Fig. 3).

established, closely spaced trees are not generally prone to bank failures, while adjacent and nearby banks that have been cleared of trees but presenting similar slopes and soils generally do experience bank failures (Fig. 2). Although, these detailed studies established this relationship for two rivers in particular, the Latrobe in Victoria and the Hawkesbury–Nepean in New South Wales, it is accepted that these findings have more general application (Rutherford, 2007) with several other studies (Huang and Nanson, 1997; Brooks and Brierley, 2000; Wasson and Wasson, 2000) demonstrating that streams presenting a dense native riparian forest tend to be narrower than streams that do not present trees or those streams that present only a few trees on their banks—the
