The 5th Sustainable Future for Human Security (Sustain 2014)

## Shear strength reduction in progress of shear displacement on the landslide near dam reservoir

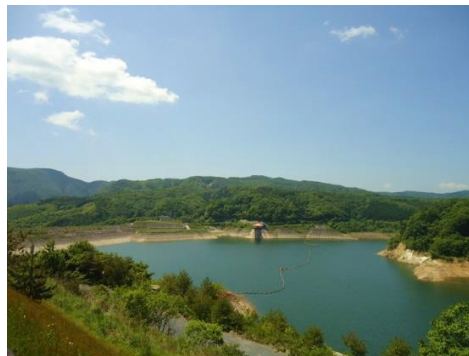
The Aratozawa dam (Fig. 1) is located in the southeast of Mount Kurikoma in the Iwate-Miyagi Prefecture of Japan. The height of Aratozawa dam is 74.4 m and length of about 414 m with the geographical position at 38°53'4.98" of north latitude and 140°51'42.93" of east longitude.

Fig. 1. Aratozawa dam and reservoir in Miyagi Prefecture of Japan (photo taken in June 2013)

According to Ministry of Land, Infrastructure and Transport of Japan, this dam was built in 1983 and categorized as rock-fill dam with central core. The main purpose of the Aratozawa dam and reservoir are flood control and
