Experimental and numerical investigation of the stability of overhanging riverbanks

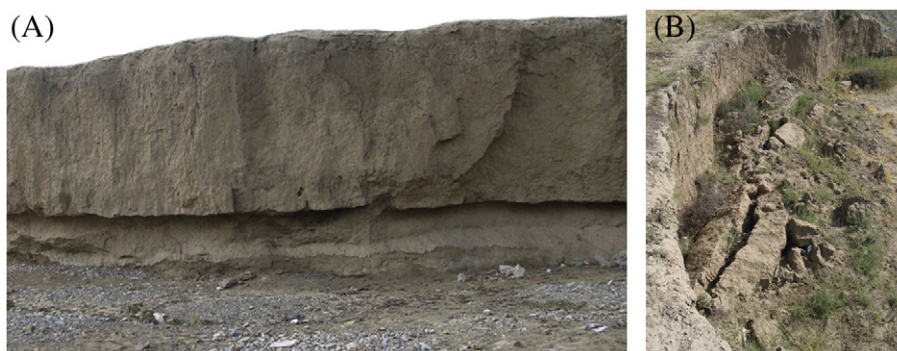
Fig. 1. (A) Fluvial erosion at the toe of a riverbank (bottom layer) results in the formation of an overhanging profile in cohesive banks of the Kordan River. (B) Destruction of the overhang from cantilever failure.

For these reasons, a study focused specifically on the overhanging failure phenomenon is necessary (see Fig. 1 for detail). Cantilever failure mechanisms have in fact recently been studied by constructing a physical model in the laboratory (Samadi, 2011; Samadi et al., 2011a); the clear advantage of this approach being the detailed observations that are possible. However, this form of physical modeling is limited to exploring a relatively narrow set of conditions because the lengthy times that are often required to construct the experiment. In contrast, numerical models may offer a more rapid setup that, in turn, implies that numerical models can be used to investigate a wider variety of different scenarios. In this paper we seek to employ the advantages of both physical and numerical modeling in a complementary approach designed to provide new insights into the process of cantilever failure. Specifically, herein we present numerical
