Desiccation cracking detection using 2-D and 3-D Electrical Resistivity Tomography: Validation on a flood embankment

Gareth Jones^{a,*}, Philippe Sentenac^a, Marcin Zielinski^{a,b}

^a Department of Civil and Environmental Engineering, University of Strathclyde, Glasgow, UK

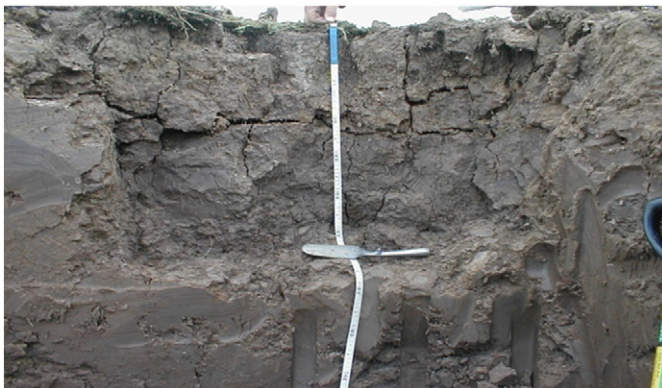
Fig. 1. Exposed fissures through trenching on the disused Thorngumbald embankment (after Dyer et al., 2009).

Research conducted by Cooling and Marsland (1954) and Marsland (1968) after the 1953 North Sea floods revealed a large number of wide cracks (≈ 10 cm) penetrating flood defences to a depth of about 1.5 m. A later study carried out by Dyer et al. (2009) on the disused Thorngumbald embankment, near Hull (UK), discovered a specific character of cracking, forming a relatively shallow (about 60 cm) interconnected network with both, vertical and horizontal fissures present. Another example from the same study shows an individual crack extending to a depth of 1 m.
