Tree-ring dating of timbers from Sabine Hill, home of General Nathaniel Taylor, Elizabethton, Tennessee, USA

Historians believe that the main two-story structure called Sabine Hill at the Sycamore Shoals State Historic Area in Elizabethton, Tennessee represents the house possibly built by General Nathaniel Taylor beginning around 1814 or 1815. We conducted a dendrochronological investigation on hewn logs and squared beams from several locations within Sabine Hill to determine the years when the trees were harvested and incorporated into the historic structure. We were able to collect and eventually crossdate tree rings from 26 beams and logs. These samples yielded a chronology spanning AD 1698 to 1818 and showed a statistically significant correlation ($r = 0.47$, $n = 121$ years, $t = 5.86$, $p < 0.0001$) with an absolutely dated oak data set composed of chronologies previously developed across the southeastern USA. We found that several logs from the cellar and one wall post were cut in 1818 while one wall post was cut in spring of 1819. One wall post from the “hyphen” room, believed to be a later addition, had a cutting date of late 1848 to early 1849. All other samples had out

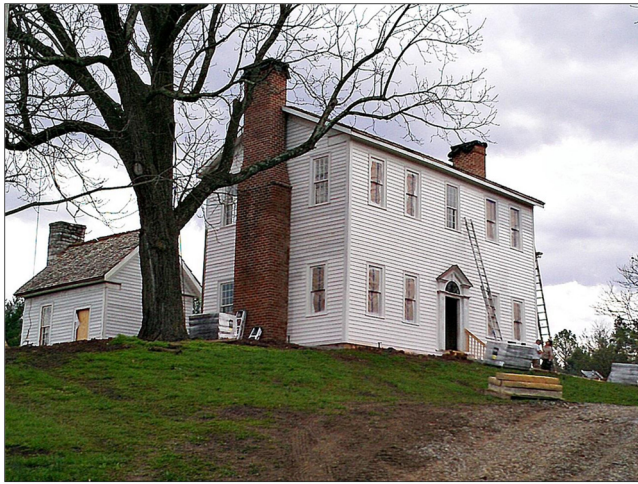
Fig. 1. The historic Sabine Hill house located at Sycamore Shoals State Historic Area in Elizabethton, Tennessee. A weatherboard-covered log pen (left) had been attached to the main house by the “hyphen” room that has since been removed during restoration.

Sabine Hill (Fig. 1) is believed to have been built beginning around 1814 or 1815 by Nathaniel Taylor (b. 1771, d. 1816) (Smith, 1936; Clawson et al., 2012), a brigadier general who participated in the War of 1812. Taylor had a distinguished military and public service career. He served as a state militia colonel for the newly-formed State of Tennessee by 1803 and was Carter County’s first sheriff and Justice of the Peace. He then served in the Tennessee state legislature from 1803 to 1805 and was a trustee of Duffield Academy in Carter County, all the while running the Taylor iron forge (Clawson et al., 2012). During and after the war, General Taylor and his troops were stationed at Fort Montgomery, Alabama. Taylor remained there until at least February of 1815 before returning to Elizabethton (Clawson et al., 2012), where he died soon after his return on 20 June 1816. In theory, trees used to construct Sabine Hill could have been harvested by family members just prior to his leaving Alabama or soon after his arrival back in Elizabethton. The construction date(s) for Sabine Hill, however, are uncertain because some historians and architects have speculated that Sabine Hill was built around 1818 (Patrick, 1981; Brown, 2005; Clawson et al., 2012) by Taylor’s widow, Mary Patton Taylor (b. 1773, d. 1853).

Sometime later, a log structure was erected to serve as an external kitchen and connected to the back of the larger house with an intervening separate room (called the “hyphen” room) to form a distinct “L” (Clawson et al., 2012) (Fig. 1). The current two story house consists of two bedrooms upstairs, two rooms downstairs (the sitting room to the east and the “Red, White, and Blue” room to the west), an unfinished cellar, and a central passageway (hall) stretching from front to back on each floor, forming a “central passage” house (Foster, 2004). Sabine Hill recently has been restored and several analyses were performed to help inform this restoration, including a conditions assessment (Clawson et al., 2012), a paint analysis (Mosca, 2013), and an archaeological report (DeCorse and Creswell, 2013). Some doubts still remained, however, regarding the suggested 1814 vs. 1818 construction dates for Sabine Hill. The primary goal of our proposed project was to conduct a dendrochronological investigation on logs and squared beams from several locations within Sabine Hill to determine the years when the trees were harvested and incorporated into the historic structure. Our sampling focused primarily on numerous vertical posts as well as a few diagonal wall braces (these were smaller in dimension) that were exposed when the walls were partially demolished during the restoration process, as well as the hand-hewn and whole logs in the cellar that serve as joists to support the first floor (Fig. 2).

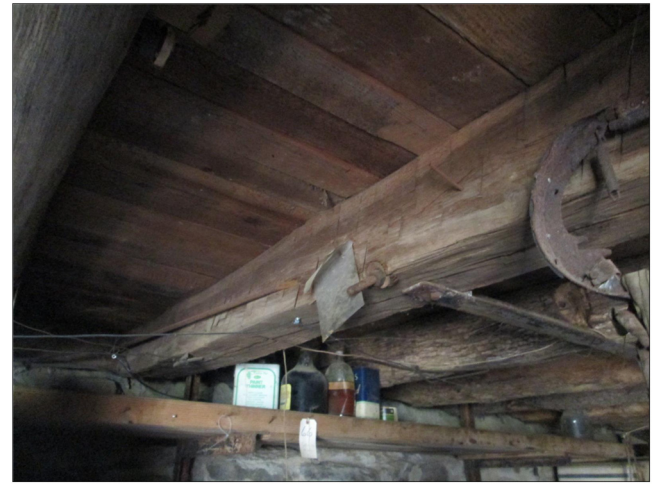
Fig. 2. First floor joists accessible in the cellar. The log in the center is hand-hewn while the log behind and to the right is un-hewn with intact bark.

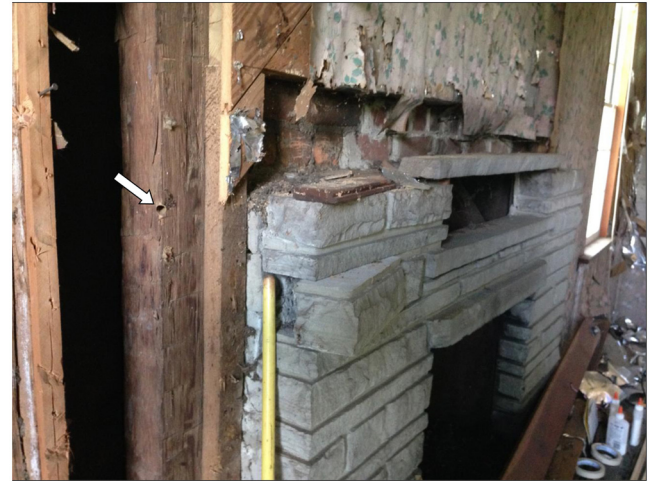
Fig. 3. Location of sample SH1005 (arrow) showing how most of the beams we sampled on the first and second floors of Sabine Hill had been squared during fabrication.

All squared structural elements had been hewn or processed with a water-powered frame (i.e. “sash”) saw based on the regularly spaced, vertical saw marks (Howard, 1989; Wilbur, 1992; Howe et al., 1997).
