Case report

The importance of computer tomography-imaging in a case of a gunshot wound with an atypical entrance wound

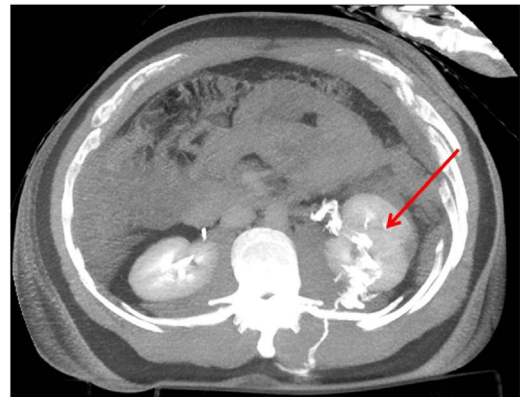
Fig. 3. Axial CT during urographic excretion of contrast medium. It reveals a complex transection type lesion of the left kidney with expansion of contrast medium outside the kidney, affecting the urinary tract, with the contrast medium revealing the path travelled by the projectile from right to left (arrow).

Upon arrival at the emergency ward a CT scan was performed using an iodinated contrast agent, revealing a lesion to the upper pole of the left kidney, with expansion of the contrast fluid from the renal pelvis (Fig. 3). It became necessary to perform a nephrectomy on the injured kidney.

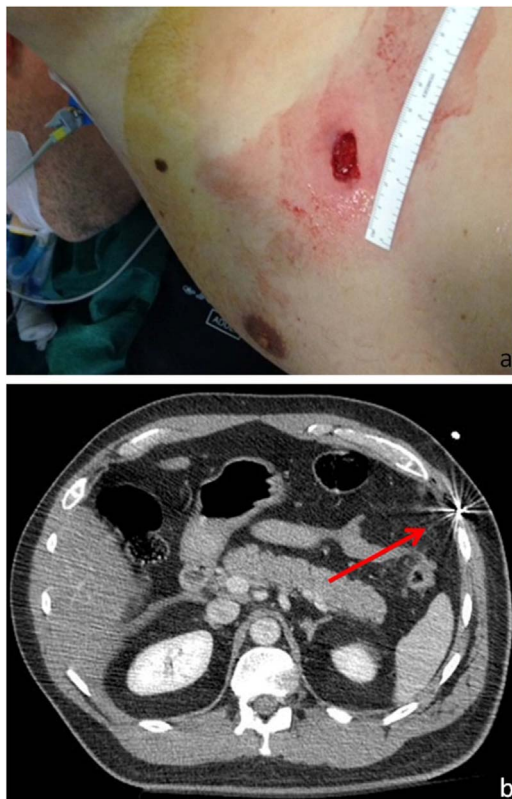
Fig. 2. (a-b): Bullet exit wound. (a) Bullet exit wound located level with the front of the left armpit, between the 6th and 7th ribs. (b) Axial CT image revealing the presence of artefacts of metallic material (arrow) in between the ribs on the front left.

The case considered here regards a 42 year old man brought to the emergency ward after suffering a gunshot injury produced by a shot fired in the course of crossfire between a number of robbers and the police. The victim had an injury in the lower back area, 110 cm above the ground and 2 cm to the left of the spinal column (Fig. 1a-b), and another injury at the left front mid axillary line, between the 6th and 7th ribs (Fig. 2a).
