Air lime mortars: What else do we need to know to apply them in conservation and rehabilitation interventions? A review

Rosário Veiga

Laboratório Nacional de Engenharia Civil (LNEC), Portugal

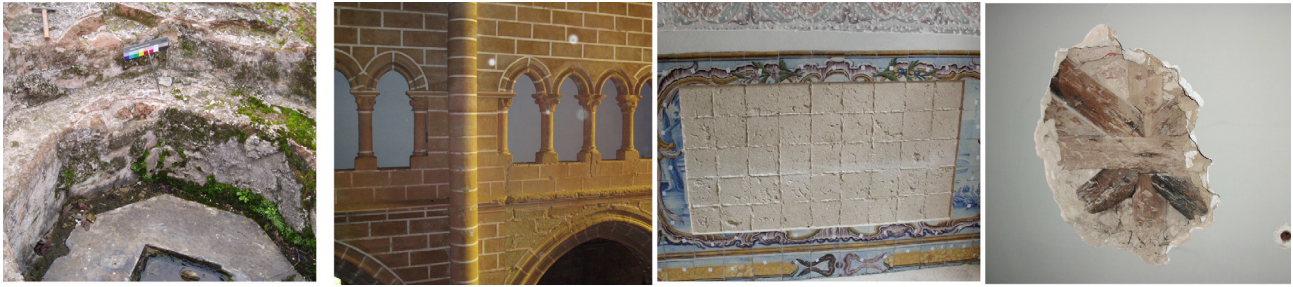
Fig. 1. Air lime mortars of historic constructions in Portugal: Troia Roman ruins; Évora Cathedral; bonding mortar of a panel of glazed ceramic tiles (“azulejos”) on the wall of a Palace; wall of an 18th century building in Lisbon with anti-seismic timber-and-lime structure (“pombalina” structure).

structural functions when used to joint stones and blocks in structural masonry walls; protection of the walls against water and impacts when used in renders and plasters; bonding material for mosaics and ceramic tiles; decorative purposes when applied in coloured finishing coats, mural painting, stuccos and so many different decorative techniques (Fig. 1).

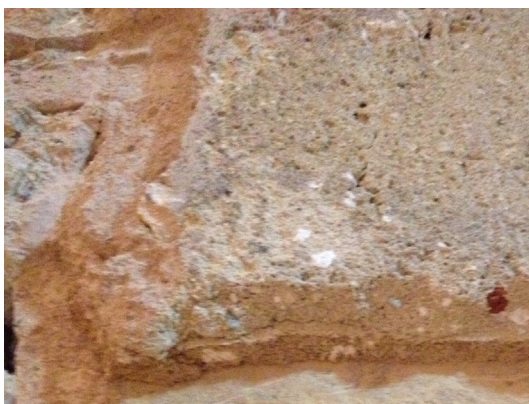
Fig. 2. White lumps in an old air lime render.

The lime mortars of historic buildings that survived until present times have very diversified compositions, in proportions, nature and quality of the main components and in types of additions. Analysis showed volumetric proportions binder: aggregate mainly in the range 1:1 to 1:2.5, or even richer in lime, but 1:3 to 1:4 and poorer are also found [15,48,49,21,50], being used for economic reasons in current constructions or resulting from loss of binder caused along time, by erosion, loss of cohesion or by dissolution as a consequence of the repeated action of water. In old mortars small white lumps of lime (Fig. 2) are often visible, sometimes attributed to non-hydrated quicklime (applied following the method of the *hot lime mix*) but which can also be due to poorly mixed hydrated powder or lime putty, or even to the re-precipitation of the calcium carbonate.
