Construction and Building Materials

Focus on soluble salts transport phenomena: The study cases of Leonardo mural paintings at Sala delle Asse (Milan)

The program of investigations on “Sala delle Asse”, which hosts a monochrome landscape attributed to Leonardo, in the Sforza Castle in Milan recently concluded the first step. Results of the analytical tests for the characterization of materials and their damages showed the high diffusion and concentration of nitrates and sulphates on the surface of the monochrome at the edge with the restoration mortars, on the right side of the north-western wall. On the base of the scientific literature and laboratory tests, the researchers identified a threshold of RH above which deliquescence of salts could easily occur. Microclimatic monitoring results informed that during the most humid days in spring, summer and fall, RH trespasses this threshold, with a frequency of about 30 events/year. After an accurate analysis of air temperature (T °C) and relative humidity (RH) resulted that the exterior changes especially affect the interior climate at some summer conditions as middle-high speed of wind and, especially, its direction due to some crac

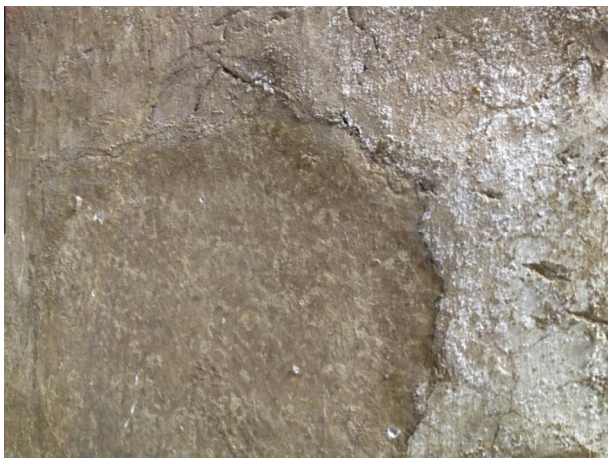
Fig. 3. Sample 1 C. Monochrome wall: white efflorescences are mainly located alongside the border of a patch composed of a different cement mix compared to the surrounding matrix.
