# Behaviour of non-loadbearing *tabique* wall subjected to fire – Experimental and numerical analysis

*Tabique* construction is one of the most used traditional building techniques and it can be found almost everywhere in Portugal with special incidence in the northeast region. *Tabique* construction elements can be described as a timber structure filled on both sides with an earth-based render. *Tabique* elements can be found in ancient buildings, from simple construction as rural dwellings to more urban sophisticated ones. This paper presents a study of the behaviour of *tabique* walls, concerning its fire resistance. Therefore, an experimental analysis was performed using *tabique* wall panel specimens. Such wall panels were made in pine wood with an earth-based render finishing. In order to assess the thickness effect of the earth-based render on the fire resistance of the wall, three specimens with different render thicknesses of 15 mm, 10 mm and 5 mm were tested in a fire-resistance furnace according to the ISO 834 [1] standard fire curve. Fire resistance is a measure of the ability of a building element to resist a fire, usually the time for which the element can meet appro

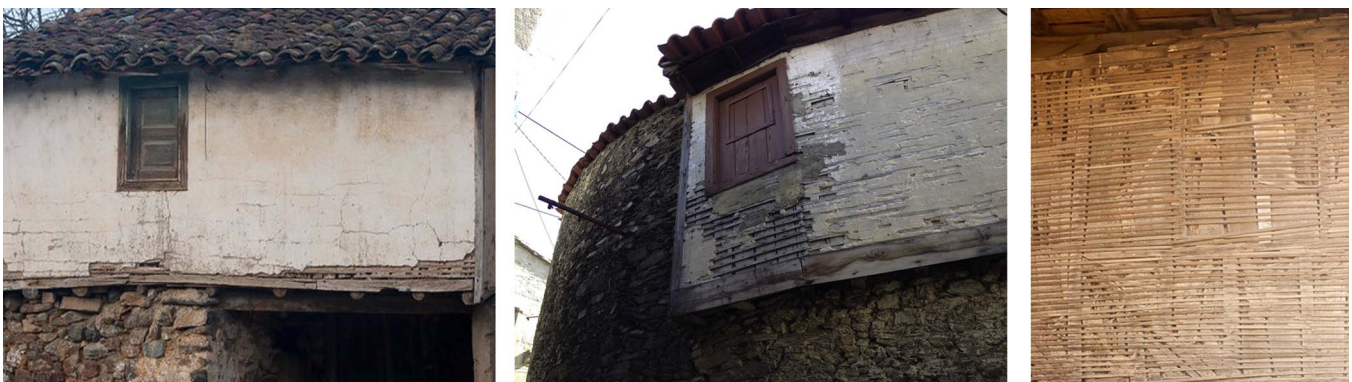
Fig. 1. *Tabique* wall building details.

The timber structure of the *tabique* panels is formed by vertical boards which are connected to each other by laths placed on both sides [9]. It was used *Pinus pinaster* and taking into account that it corresponds to a current applied solution [3]. These timber elements are nailed. This timber structure was then covered with an earth-based render corresponding to a traditional building solution. Fig. 1 shows some building details of typical *tabique* walls.
