# Versatility of steel in correcting construction deficiencies and in seismic retrofitting of RC buildings

This paper presents the structural upgrade of a public school building, which did not guarantee safety against collapse under gravity loads and which had been designed ignoring seismic actions.

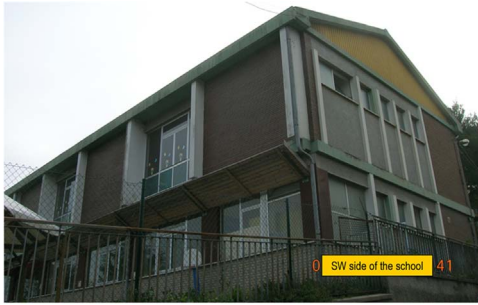
**Fig. 1.** Public school building located in Montelabbate, close to Pesaro (Italy). Long wing of the building: front of the school, which faces onto the garden, and lateral side that faces onto the street. The school complex was built in 1964.

This paper deals with a public school building (Fig. 1), located in Montelabbate, a town close to Pesaro, in Italy (Marche Region), which had been destined for demolition. The building represented a typical RC framed structure of the 1960s. Although not being a 'Listed Building', the edifice was of interest and importance, since it was of good quality design and appearance. Moreover, not only was the

inserted into the walls that separated the classroom from the corridor (Fig. 6); the edge frames were inserted into the external walls (Fig. 7). Hence, the structure was not visible, except for some of the vertical structures of one edge frame, which were walls instead of columns, but for esthetic purpose only (Fig. 1).

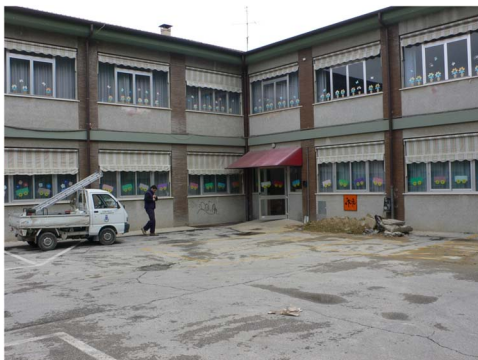
**Fig. 2.** The school complex is composed of the classroom building, the gym and a porch. Long wing (on the left) and short wing (on the right) of the classroom building: school's backside, which faces onto the courtyard.

The complex was, and is, composed of the classroom building, the gym, and a porch that connects the former to the latter (Fig. 2). This paper focuses on the classroom building, which is the main part of the complex (Fig. 3). The classroom building, which has L-shaped plan, is composed of a long wing and a short wing, joined to one another by the atrium (Figs. 2 and 4). Both of the wings are made up of the first story (ground story), the second story (first level), the attic (third story and second level), and the roof (gable roof; top level). The long wing also presents a small basement.

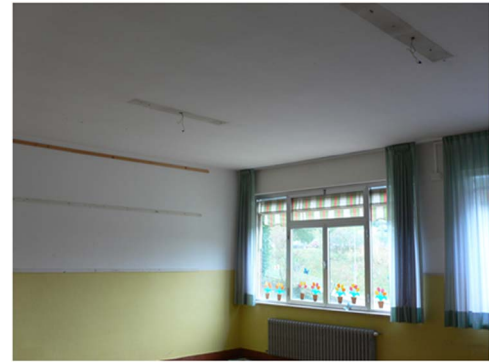
**Fig. 3.** One of the classrooms on the ground story. The photo also shows the drop ceiling, which allowed the new transverse beams to be covered.
