Characterisation of the wear mechanisms in retrieved alumina-on-alumina total hip replacements

P. Zeng^{a,*}, W.M. Rainforth^a, T.D. Stewart^b

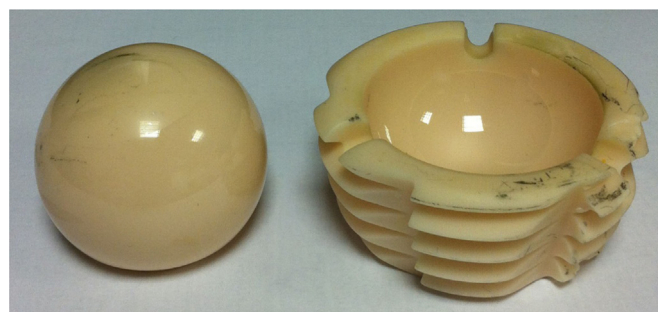
Fig. 1. A pair of retrieved *in vivo* alumina femoral head and acetabular cup.

7 pairs of retrieved alumina-on-alumina THRs were investigated and the details of each pair are given in Table 1. An example of the retrieved *in vivo* alumina femoral head and acetabular cup are shown in Fig. 1. The alumina ceramics used for operations were Biolox[®] alumina ceramic material with a mean grain size of 3.2 μm and a density of 3.95 g/cm^3 .
