# Non-destructive inspection of aircraft composite materials using triple IR imaging

*Keywords:* composites, thermography, aircraft inspection, NDT, data processing

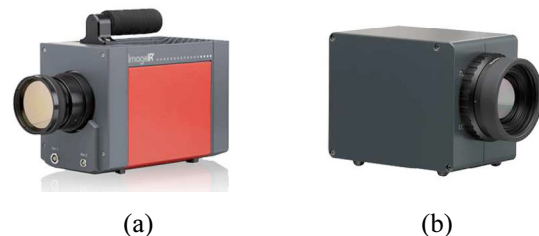
**Figure 2:** The ImageIR 5300 (a) and the VarioCAM hr head 600 (b) that were used in the experiments

The Infratec ImageIR 5300 IR camera was utilized for Mid-wave inspection of composites with a geometric resolution of 320x256 pixels, thermal resolution of <0.015K at 30°C and a spectral range of 7.5–14 $\mu\text{m}$ . For the inspection at the long-wave range, the Infratec VarioCAM hr head 600 camera was employed with a geometric resolution of 640x480 pixels, thermal resolution of <0.03K at 30°C and a spectral range of 7.5–14 $\mu\text{m}$ . Figure 2 shows the aforementioned cameras.
