Symposium of the International Society for Rock Mechanics

## Stability Analysis of an Over-Tilted Slope in a Granite Quarry: the Role of Joint Spacing

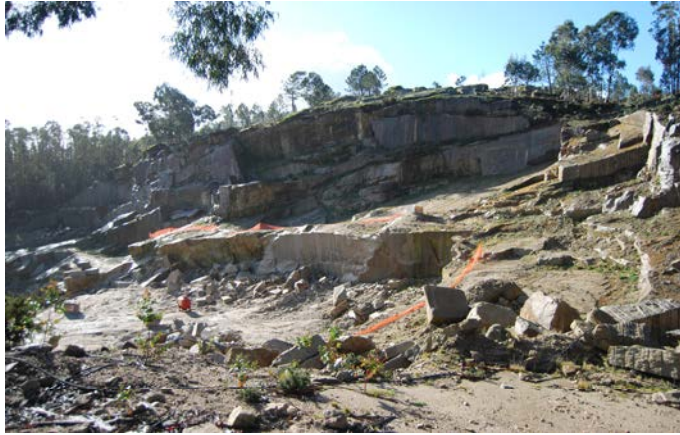
Fig. 1. General view of the general quarry slope roughly 40 m high.

This paper presents the case study of a stability analysis of an over-tilted (inverse) slope in a granite quarry. Due to space constraints of the quarry located in a hill slope, the SW end of the quarry happens to be parallel to a set of highly persistent joints that were dipping around 80° counter-slope. Therefore, as shown in Fig. 1, large parts of

the slope are overt-tilted, that is, the slope is inverse –dips more than 90°– in these areas. In such situations, the local mining regulations enforce the owner to carry out a slope stability study appropriately justifying the stability of the slope. In this paper, the authors presents the most relevant topics of this geomechanical study, together with some considerations regarding the actual occurrence of instability toppling phenomena in rock slopes.

The quarry is located in the municipality of Tui in NW Spain. Fig. 1 shows a general view of this exploitation. The quarry activity is mining local slightly weathered granite, whose commercial name is ‘Silvestre Moreno’. Quarry production tends to be around 100,000 m<sup>3</sup> per year according to market evolution. Final products of the quarry are granite blocks, semi-blocks and ashlar masonry; appropriate descriptions of these products are provided below. The exploitation method is quarrying using black powder to cut the rock following the typical three weakness directions and recently diamond wire has been introduced in the quarry to make precise vertical cuts in the stone, improving recovery levels in the extraction of the ornamental rock.
