6th Asia Pacific Workshop on Structural Health Monitoring, 6th APWSHM

Large structures monitoring using unmanned aerial vehicles

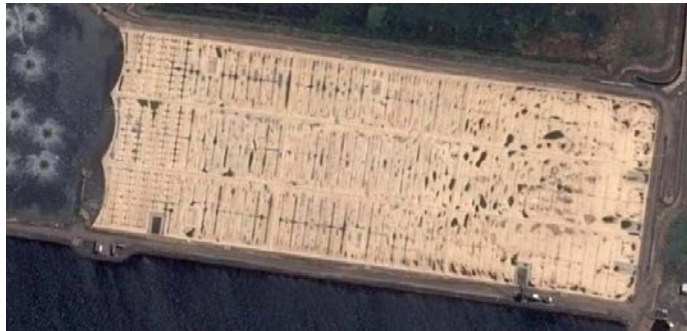
Fig. 1. Aerial view of the floating cover at Melbourne Water Western Treatment Plant as seen from Google Earth

The floating covers used in Melbourne Water's Western Treatment Plant (WTP) in Werribee, Victoria, are made from high density polyethylene (HDPE). They are 2 mm thick and typically span an area of 470 m x 170 m, as illustrated in Figure 1. The cover is held down around its perimeter by clamping strips and mechanical fasteners to provide an airtight seal. All sewage inflow is unscreened and passes first through an anaerobic reactor. As the raw sewage undergoes anaerobic digestion, biogases are produced, which are trapped below the floating cover and harvested for electricity generation. Consequently, there is a high premium placed on ensuring that no failures occur in service. The current maintenance practice involves a visual walk-around inspection which is potentially hazardous and time-consuming, but, more importantly, does not provide advance warning of possible failures, or clear indications of distress in the covers. Indeed, a powerful incentive for this proposal is the recent catastrophic failure of a cover sheet at the Melbourne Water treatment plant in December 2014, as shown in Figure 2.
