World Multidisciplinary Civil Engineering-Architecture-Urban Planning Symposium 2016,  
WMCAUS 2016

## Cantilever Steel Industrial Building Located on a Rocky Hill

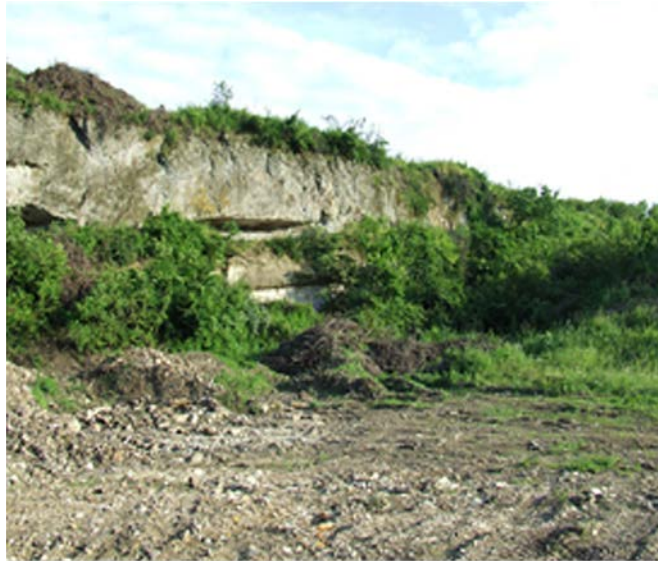
Fig. 1 – Abrupt 14.0 m rocky wall.

A short description of the site, from ground condition point of view, is quite relevant and fully justifies further technical solutions. Figure 1 presents the site configuration and the abrupt 14.0 m step represented by the existing rocky wall. As a result of the performed geotechnical survey (following two 8.0 m deep rock drilling), starting from the surface, successive layers of vegetal soil, then altered / cracked volcanic rock and deeper compact volcanic rock have been found. At 2.50...2.80 m depth (recommended depth of foundation), semi-compact rock with a conventional allowed pressure  $p_{-conv}=500$  kPa has been identified. Furthermore, a low geotechnical risk of foundation ground damage has been estimated by this study, by underground water or cracking of the rock.

At the same time, landslide danger still persisted, starting from the top of the presented wall, under upper building pressure. Besides the conclusions of the geotechnical survey issued after two drillings only, supplementary caution had to be taken with the occasion of up-hill infrastructure excavations, trying to identify ground aspect and possible rock crack initiating (in order to avoid an overall collapse of the rocky wall by global shear).
