## Downpipes and upper story latrines in Pompeii

A. Kate Trusler<sup>a,\*</sup>, Barry Hobson<sup>b</sup>

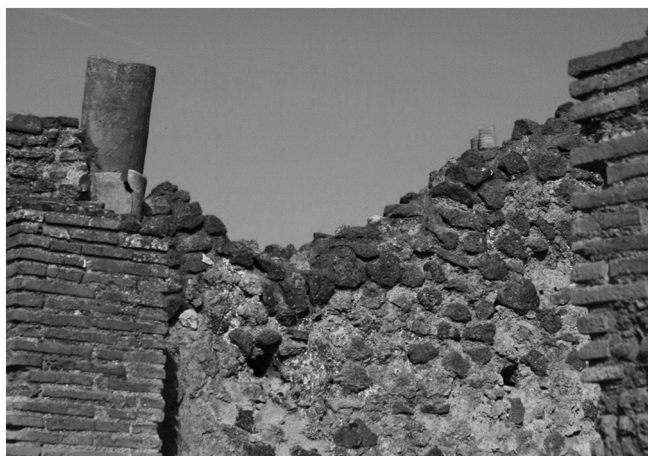
Fig. 1. Wide-bore downpipe in VI.14.7 with two narrow-bore water pipes visible in the adjoining property (VI.14.6).
