Original article

State-of-the-art technology on conservation of ancient roofs with timber structure

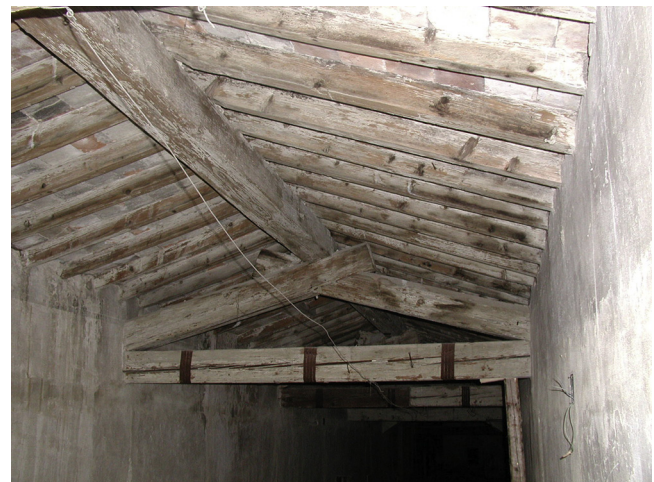
Fig. 1. Absolutely useless fastening with iron strap of a truss tie affected with a check caused by shrinkage (Villa Demidoff, Florence. Photo Tampone).

A recurrent interesting example is constituted by the practice, mainly operated in the 18th and 19th century, of fastening the damaged sections of a broken member with several circles of continuous wrought iron strap (Fig. 1); the measure is ineffective and sometimes dangerous due to the high deformability in every direction of the iron ribbon and to its prompt rusting.

Severe hygro-thermal and aesthetic problems arise since the measure requires to hide a large extension of the member.

The strap can be removed but irreversible damage is brought to member surface by the very high number of nails to be removed. The application of plates at the lower edge of the members in order to increase the depth of the section and, at the same time, lend additional tensile strength to the member is an obsolete practice, moreover not effective if not integrated, as generally made, by the application of devices resisting compression at the upper edge. The application of resistant lamellas at the faces of the member, inserted in superficial horizontal slots made on purpose, is to be considered ineffective and not respectful of the mechanic peculiarities of the wood due to the tangential stresses that the lamellas exert on the wood.
