Original article

Microwave and radio wave supported drying as new options in flood mitigation of imbued decorated historic masonry

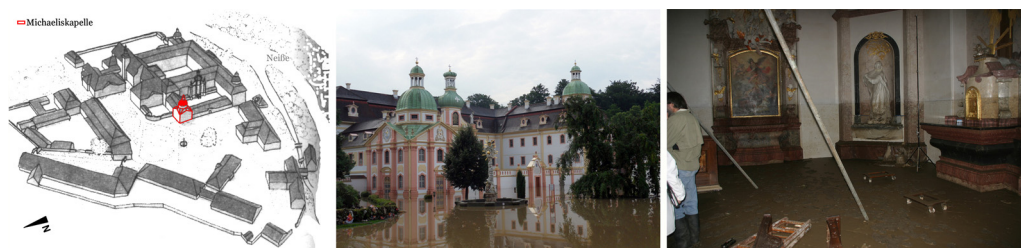
Fig. 1. Convent Marienthal at Neisse River with the chapel St. Michaelis (“Michaeliskapelle”, left), situation after the 2010 flood event at the monastery area (middle) and in the chapel St. Michaelis with the maximum water level clearly visible by the darker color (right).

On August 7th and 8th, 2010, the monastery of Marienthal (Fig. 1) was heavily affected by a flood event of the nearby Neisse River. Several days of very heavy rains had raised the river levels in the entire Neisse region at the national border between Germany and Poland. Retaining reservoirs could not hold the water any more resulting in a flood wave running along the river basin. Although notably flood protection arrangements including mobile protection parts had been installed after an earlier event the disastrous flood of 2002 the actual flood mark exceeded the expected level and entered the rather protected monastery area. Most of the rooms in ground level and namely the church, the cloister and many rooms of the convent were deluged by between 1.5 to 2.3 m in height depending on the absolute floor level. It was the highest flood event

in the history of the convent. Some of the valuable cultural mobile parts could be rescued in due time by some nuns but immobile parts got heavily affected. It took about one day for the main water to run off. Mud and floating refuse were left behind. Naturally, all lower building masonry parts were heavily moistened (Fig. 1).

a key function of the plaster, drying of the totally wet masonry is all but impossible. However, the chapel of St. Michaelis (Fig. 1) has a regular plaster on the outside, which was advantageous in the drying context. Therefore, there was no constraint to remove the outside plaster. In contrast, the situation inside the chapel was much more demanding because the wall is completely decorated with a historical stucco gypsum plaster as false marble interior. Saving the original material in place was of paramount importance in preserving cultural this heritage. Beside the sensitive stucco gypsum plaster, the masonry composition also included brickwork and rubble masonry. Against this background, the investigations consisted of analysis and test applications at the chapel accompanied by investigations on a special test specimen. The test specimen allowed destructive sampling and check also critical conditions for the application of drying methods without damaging of the heritage material. The false stucco marble consists in large parts out of Gypsum ($\text{CaSO}_4 \cdot 2\text{H}_2\text{O}$), which begins dehydration in the range from 42–60 °C [4]. Although gypsum shows almost no shrinkage after drying and dehydration, rewetting leads to clear increased volume [5]. This swelling effect influences the bond properties with the substrate material due to different expansion and can cause delamination.
