Characterization of URM buildings and evaluation of damages in a historical center for the seismic risk mitigation and emergency management

M. Vona^{a,*}, G. Cascini^a, M. Mastroberti^a, B. Murgante^a, G. Nolè^b

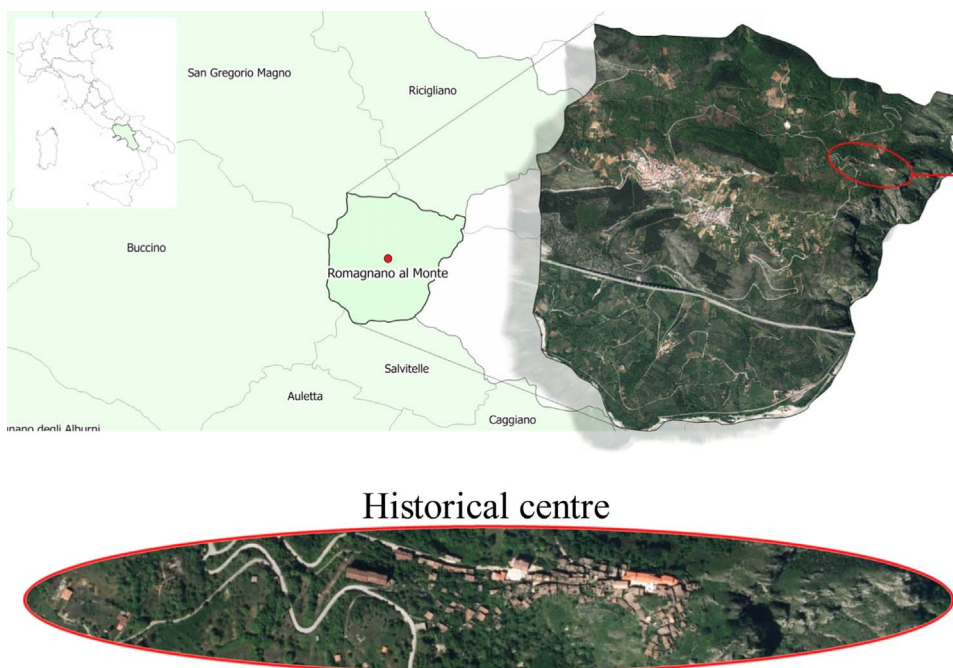
Fig. 1. Localization and aerial view of the Romagnano al Monte village.

In this paper, the results of a survey of a damaged historic center are reported. The survey uses an integrated approach with different survey methodologies and tools. An interesting case study has been considered: Romagnano al Monte (Salerno, south of Italy, Fig. 1). It can be considered as an unique "open" laboratory.

A typological characterization of URM buildings and their damage is reported. The case study is the historical center of Romagnano al Monte (Salerno, south of Italy, Fig. 1). Its origins date back to the Middle Ages when a castle was built, approximately in the year 1000 A.C. It was located on the top of a rocky spur. On November 23, 1980, an $MW = 6.8$ (CPTI15, Italian Parametric Earthquake Catalogue 2015) earthquake shook the south of Italy (Irpinia Earthquake). In the town of Romagnano al Monte, in the epicentral area, the macro seismic intensity was characterized by a value of $IMCS = VIII-IX$, but the town was not destroyed to the same extent as other nearby towns.
