Total Talar Prosthesis Replacement after Talar Extrusion

We report the preliminary results of the first European case of a prosthesis replacing the talus in the aftermath of severe talocrural trauma.

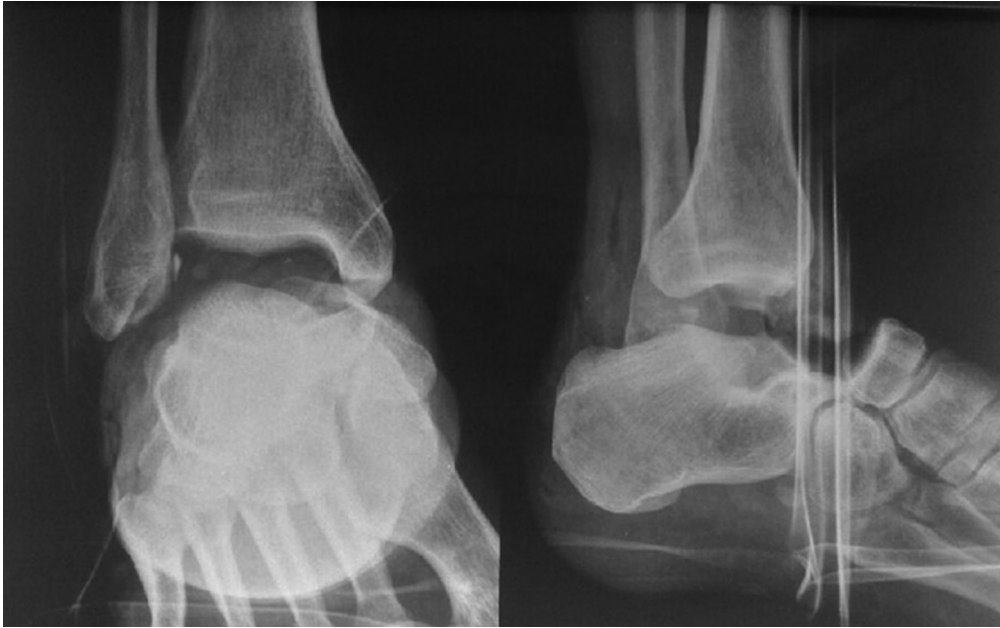
Fig. 1. Preoperative radiograph showing the talus completely missing.

The computed tomography scans taken on arrival at the first hospital revealed a clear space in the tibiotalar interval, corresponding to the missing talus (Figs. 1 and 2). The wound was situated transversely below the lateral malleolus. Clinically, no distal neurovascular injury was detected.

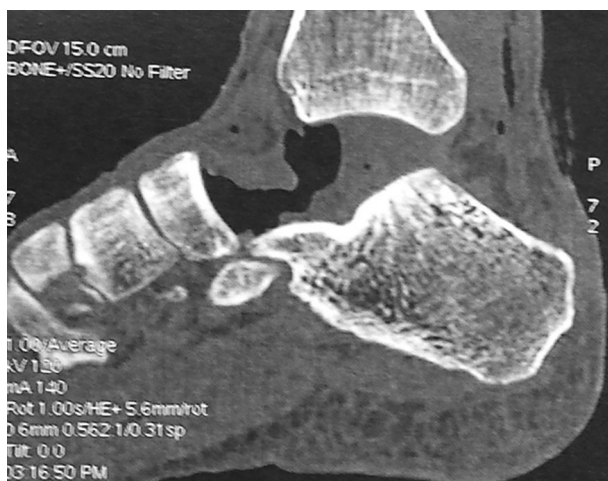
Fig. 2. Computed tomography scan, sagittal view, showing the talus completely missing.

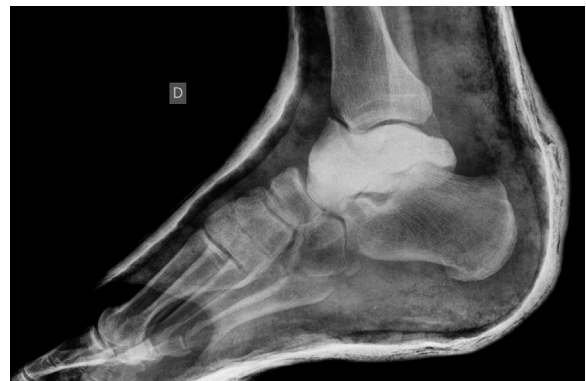
Fig. 3. Postoperative follow-up radiograph showing the spacer positioned in the tibiotalar space.

Emergency surgery was performed, which consisted of abundant cleansing of the joint and trimming and excision of the contused subcutaneous tissues. An antibiotic cement spacer was positioned to stabilize the clear space and avoid capsular ligament retraction and was molded to fit against the adjacent joint surfaces (Fig. 3).
