Inferior Vena Cava Filter with Pancreatic Penetration and Complex Retrieval Complicated by Renal Arterial Injury

Editor:

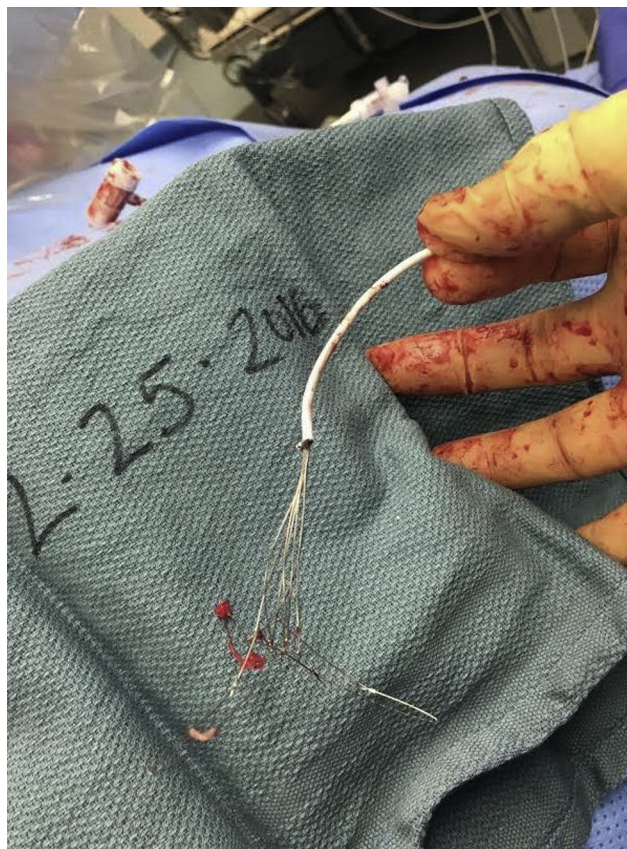
Figure 4. An immediate image taken of the explanted filter after visual inspection confirms the filter to be intact without fractured or missing components.

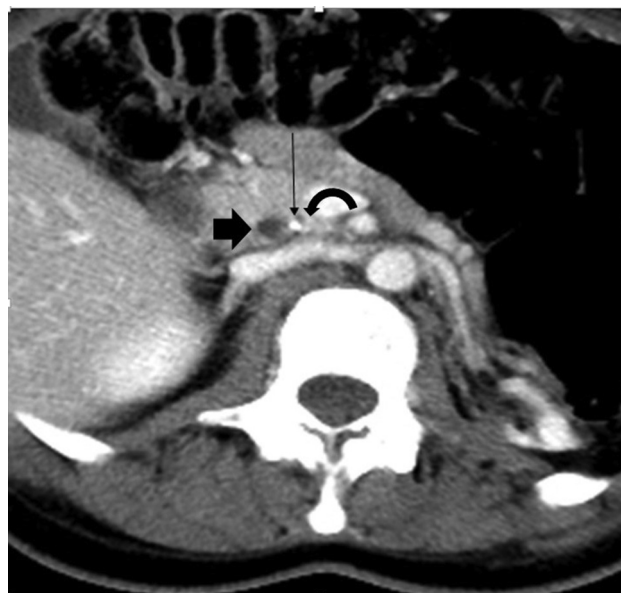
Figure 1. Preprocedural CT demonstrates the apical hook of a Günther Tulip filter (narrow arrow) embedded into the pancreatic head between the common bile duct (wide arrow) and the pancreatic duct (curved arrow).

patient's overall concerns for long-term filter safety, IVC filter retrieval was planned. On CT evaluation, the apical hook and the conical tip of the filter showed penetration across the anterior IVC wall and into the pancreatic head (Fig 1). The medial leg of the filter extended into the aortic wall (Fig E1 [available online at www.jvir.org]). The anterior leg of the filter was abutting/penetrating the duodenum. The posterior leg of the filter had penetrated a vertebral body with visible bone remodeling, and exhibited fracture (Fig E2 [available online at www.jvir.org]). Aortic angiography before filter manipulation was performed to assess the filter leg extending toward the aortic wall and to establish arterial access in the event that aortic intervention would be needed. The vascular surgery team was on standby for the procedure in the event that urgent surgical intervention would be necessary.

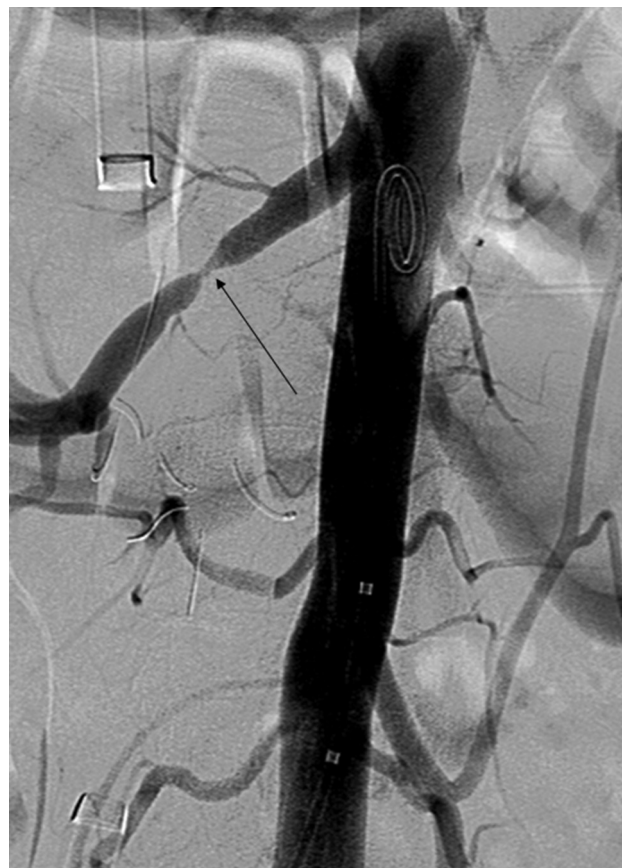
Figure 3. Postretrieval aortic angiography demonstrates acute, high-grade stenosis (arrow) of the midportion of the right renal artery.
