Case Study

Vegetation Restoration on the Pecos River in East Central New Mexico: Lessons Learned

By Scott Stovall

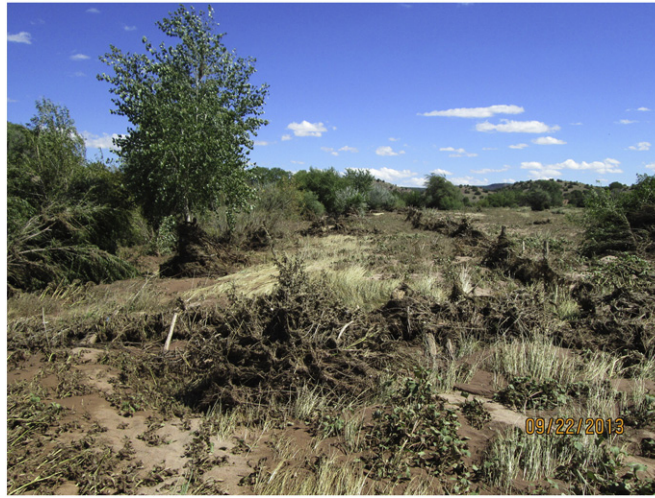
Figure 1. Restoration area after a flood; notice debris stuck on fences. Cottonwoods are former transplants. The Pecos River (unseen) is to the left.

Cattle eat cottonwoods. Horses do not, unless they do not have anything else to graze on; then they will chew on the bark of small young trees. Fencing was key, and it had many benefits other than just keeping cattle out. One of the greatest benefits was that the fences retained soil and debris behind its borders during floods, sometimes adding up to two to four vertical feet to the banks from each flood (Fig. 1). Fences that

ran at a 90-degree angle to the river were able to retain the majority of flood silt and debris as the flood water made its way through, and in some cases, the silt completely covered a four-strand wire fence.
